Pierced Traction Cables

Ref: NRB23-07

Date of issue: 29/06/2023

Location: Gillingham & Gravesend, Kent

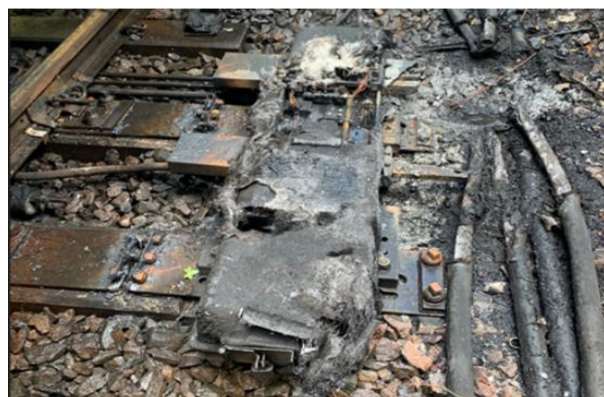
On 4th May 2023, EK2033B points at Gillingham pierced a live traction cable that had become caught in the point machine. The incident punctured the insulation of the cable causing a short circuit and damage to the point machine. The short circuit meant that the lock/detection blades became live and could have caused injury to any operator using the manual winding mechanism.

The section of cable which was pierced was due to be replaced as part of planned project work that night. The coiled-up section had been delivered to site for this replacement work. This cable was propped up against the wall and subsequently slipped down, pushing the live cable section towards the point machine. Subsequent operations of the points led to the machine blade ends coming into contact with the cable and ultimately pierce / puncture its insulation layers, exposing the live conductor cable. Following a point movement, the lock / detection blades came into contact with the live conductor causing a short circuit.

- Are you and your team fully checking for the proximity of traction cables during points maintenance?
- Are you and your team storing and securing materials in a safe way, thinking about how it might move and what might happen if it did?
- Are you compliant to the cable separation standard (NR/L3/ELP/27250/CRE805)? Remember, no traction cable should be within 500mm of a point machine.

- Fully checking the proximity of traction cables points machines during CRE inspections?
- Installing additional mechanical cable protection where required e.g., Yellow Split ducting or troughing?
- Re-routing cables where it is identified clearance is insufficient from other assets?

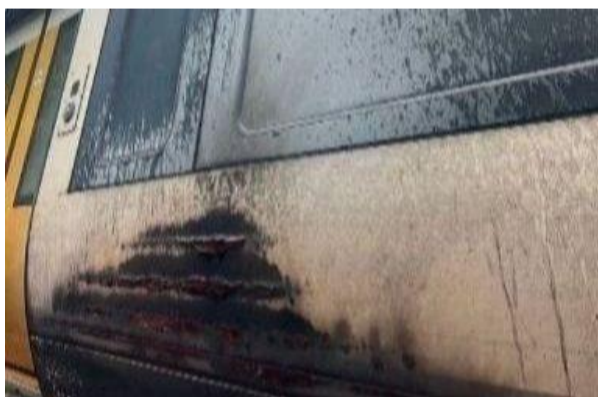
On 19th June 2023, NK2251B points at Gravesend pierced a live traction cable that was near the machine. During operation of the points, the movement of the lock and detection blades (with threaded ends) punctured the insulation of the cable. 2L31 then passed over the points and this additional pressure created a catastrophic short circuit that destroying the point machine, 4 traction cables, sole plate & stretcher bar insulations as well as track circuit equipment. It also damaged a train that was stopped over the crossing.

The Route has commenced a specific check on all point machines on the area and already identified two further point ends where action is required to remove the risk.
