Safety Alert

Lifting Auger Separated from Lifting Cap

Lessons Learned

Auger Lifting High Potential Incident

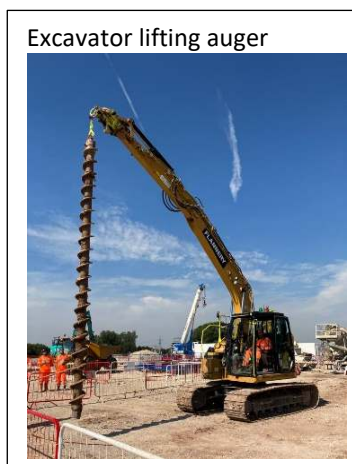
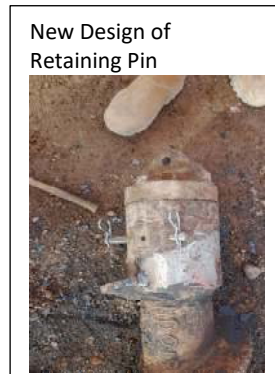
Photographs

During a lifting activity, a 15t excavator was lifting a 360mm x 6m auger, estimated 750kg, which separated from the lifting cap. The Auger in the vertical position was lifted 500mm above ground level and was tracked a short distance. It then separated, dropped to the ground on its end, then pivoted towards and struck the excavator. The machine sustained damage to the handrail/walkway. There were no injuries. The lift team were in a place of safety and the area was under control of the Slinger/Signaller.

When lifting augers, the planning and delivery must ensure the use of correctly designed retaining pins. The pins supplied to secure the lifting cap in the case of this incident did not have a retaining mechanism, consequently during the lift when oriented in a specific direction the pins could come loose and fall out.

- New pin design now supplied with retaining 'R clip' to prevent accidental release. A secondary control measure of a choke chain on the auger is also used.
- Increased size excavator now deployed to ease height reach issues
- Lift Plan revised to include specific detail related to excavator lifting in this restricted headroom area
- Specific Task Brief for auger removal and replacement has been developed with the team and communicated
