Safety Communication

Doc Ref: VAC29112023

Date Sent: 01/12/2023

Communication Title: VAC EX High Potential Near Miss M53

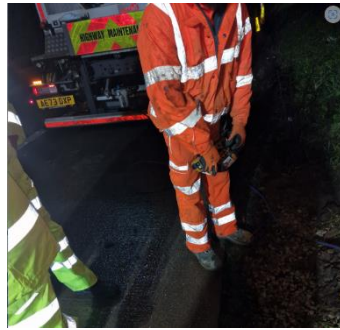
On the 29th Nov 2023, whilst attempting to clear a blockage in the nozzle of a Vac Ex Machine the arm of the operator was sucked into the nozzle opening into the pipe. While the second operative was breaking up soil within the excavation at the time of the incident.

A member of the civils gang spotted the incident and activated the emergency stop, releasing the operator from the machine.

On this occasion the operative concerned was not injured and had a lucky escape. A full investigation is underway to determine the root cause of the incident.

- Nozzle Blockage created the need for clearance.
- Fans left running creating suction once blockage cleared.
- Operative working in a position under the nozzle and arm.

- Low temperature causing the spoil to freeze and block the pipe.
- RAMS blockage procedure did not state to isolate the machine.
- Second Operative was in the vicinity loosening soil in the excavation not assisting with the blockage.

- Blockage procedure amended in Safe System of Work and trained out to the operators and immediate teams.
- All supervision in charge of Vac Ex operations are made aware of CPA safe operating guidance.
- All blockage clearance operations are to take place with the machine turned off and isolated.
- The PC has briefed the on-site teams regarding Vacuum Excavator Safety and the correct procedure for clearing blockages.
- An MSF Safety Communication has been released.
- 3-day interim investigation has been published.
- A full investigation is being performed

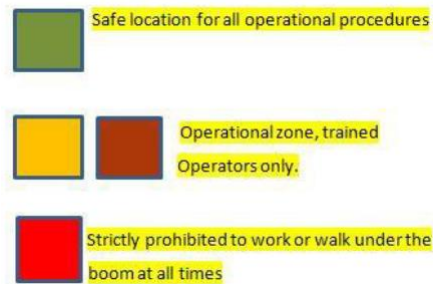
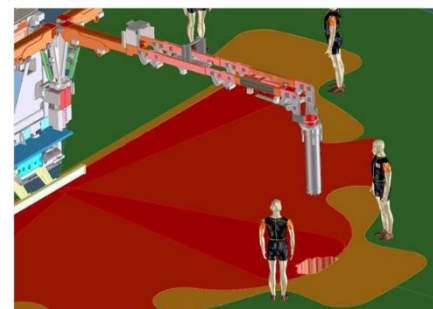
Safety Zones on Vacuum Excavators

- RAMS did not state correct blockage clearing procedures.
- Second Operative should have been on the controls during blockage clearance.
- Machine should be isolated prior to clearing blockages.
- Operatives must stand in the correct position to clear blockages from Hose Nozzles
