# Safety Alert

It was reported that on 02/01/2024, a street lighting lantern in the central reserve (lighting column No. 392/008 at M4 J5) became loose from the bracket and was suspended by the lanyard during Storm Henk. The Storm blew the swinging lantern which caused it to strike the column. The highest wind speed was recorded to be 88.9km/h at nearby Heathrow Airport.

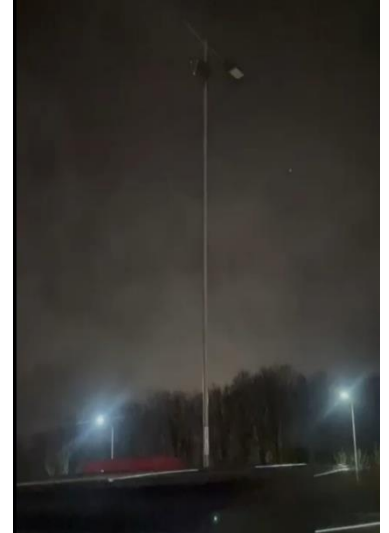
Lantern detached and hung by lanyard During Storm Henk

- When observed that a lantern is detached from the bracket, this should be reported to ROCs to implement emergency TM and speed restriction to establish a safety zone immediately in case the lanyard breaks.
- Once it is safe to access, maintainers should remove or reinstate the lantern immediately.
- Installer shall install in accordance with manufacturers' specification and installation requirements such that the system will meet its declared performance.
- Installers shall follow installation manuals to use appropriate tools and materials (including correct spigots) and keep all detailed installation records.
- Toolbox Talk and quality assurance documentations shall be reviewed to ensure they are up to date.
- BBV is undertaking a quality review on the specialist subcontractor.

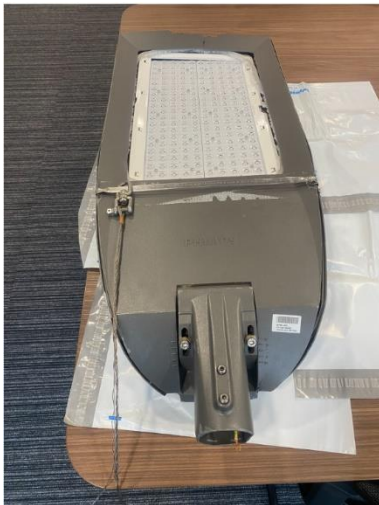
The Area 5 maintainer was called to attend the site. While the Area 5 maintainer (CPS) were waiting for the lane closure to collect the swinging lantern, the lanyard broke, and the lantern fell to the ground at approx. 16:30. No members of the public were affected because of the falling lantern. The lantern was recovered safely.

Fallen Lantern and Spigot

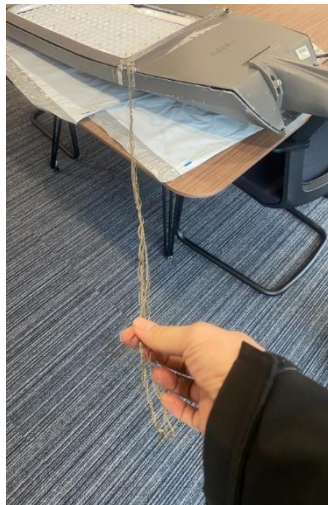
Snapped Lanyard

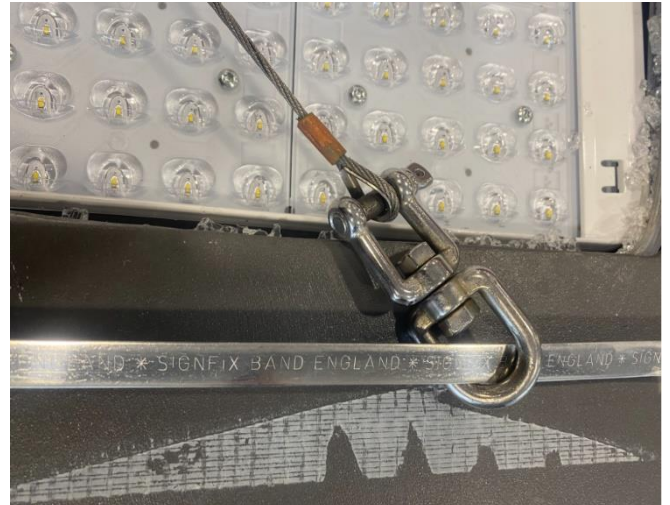
D-Shackle fixing detail

- It is noticed that the locking wires are missing on the D-shackles at all locations.
  - 1no lantern was found to have 1 grub screw spinning in place and the other grub screw torqued to 20Nm

- National Highways SES team is leading an investigation to find the root causes and provide any possible further rectification advice, this is currently ongoing.
- Balfour Beatty Vinci and the specialist lighting installers to inspect all installed lanterns to rectify any identified defects on spigots and lockwires.
