# STOPThink! Piling Incident

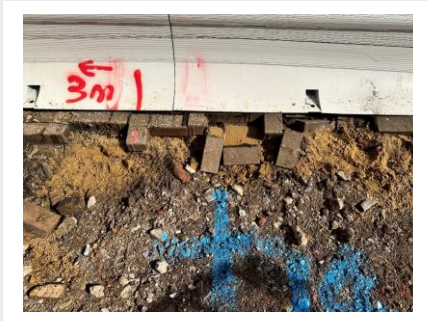
Block paviours adjacent to the piling location

The pot which guides the augers during installation, caught the rear of a line of block paviours which form the platform surface. The paviours were pushed towards the track which subsequently pushed 11 copers towards the track.

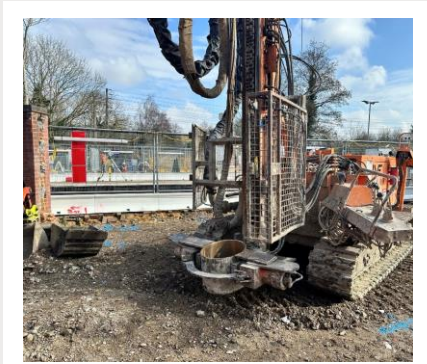
Piling rig utilised at time of incident

A Klemm 709 2 SFA piling rig was being moved into position at the rear of the railway platform 2 (down line) at Farnborough North station. A banksman was guiding the operation.

- Where works are using items of construction plant, a robust plan must be in place to ensure that clear communication can be made between the banksman and the operator of the equipment.
- When working on rail projects with any construction plant Duplex communication equipment (DECT Comm) must always be used for this purpose.
- The risk assessment should consider how the works could impact the operational infrastructure and suitable control measures should be implemented.

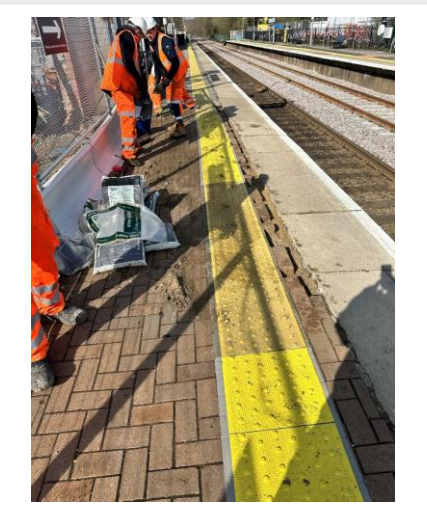
Repairs being undertaken to platform

Repairs were undertaken to realign the copers and ensure that the platform was safe for trains and travelling public.
