octavius

STOP.
Think!

May 2022

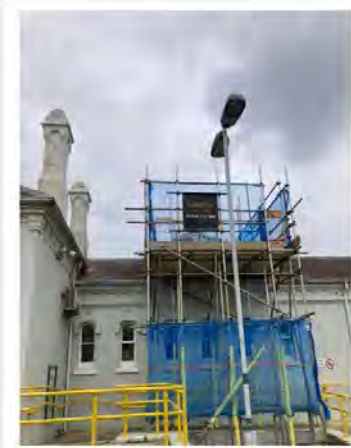
Scaffolding at Shoreham station

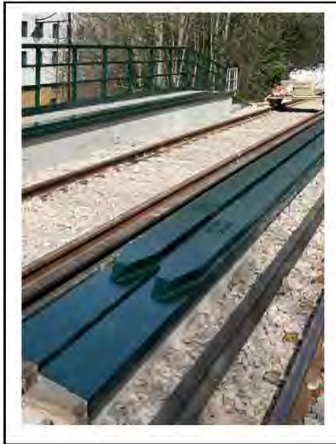
Gap in central girders

A member of the public alerted our project team that they had found a bolt on the footpath below a bridge that was being worked on. It is possible that the bolt may have fallen through a gap between the two bridge sections. All operatives working on the bridge deck were immediately briefed to not place anything on the bridge girders. An inspection of the girders was made to ascertain if there was a possibility that other items could fall between them.

Octavius and Network Rail staff immediately went down to road level to inspect the area for any other items that may have fallen, but none were found. The member of public had moved the M12 bolt to a fence adjacent to the footpath and had left the scene before any formal account could be taken. The M12 bolt was retrieved and taken back to the site office.

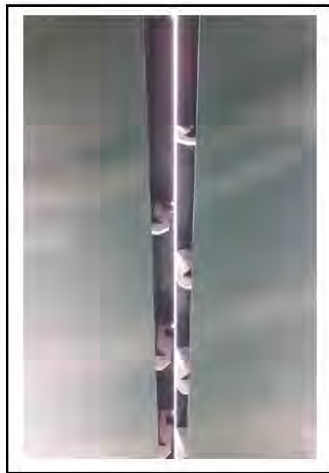
View of gap from below

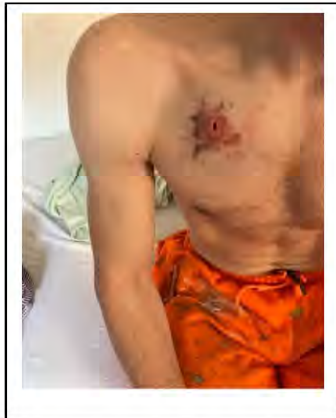
Injury from the broken glazing

Octavius is undertaking a project to replace the canopy glazing at Weymouth station. During the works, one of the glazing panes broke and an operative received a cut to his chest.

The glazing panes had been removed utilising a MEWP to access high level, the pane of glass was placed onto the MEWP deck and it was lowered. As the pane was being removed from the MEWP, it struck a section of metal beam which caused the glass to break.

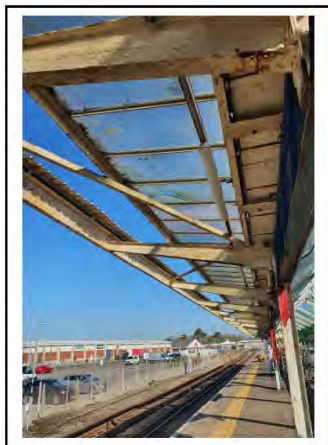
Station canopy with similar glazing panes in situ

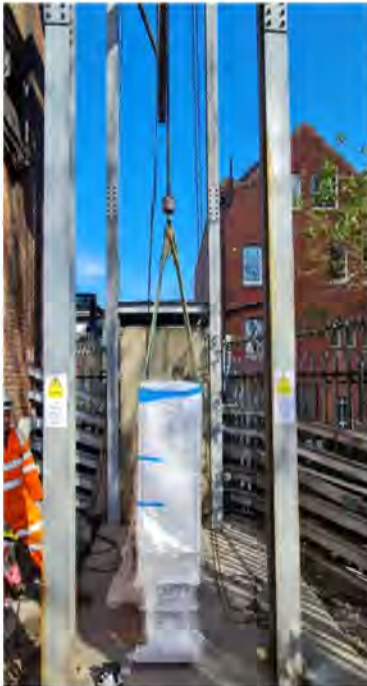
Replication of lifting arrangements

Whilst the LCP was being traversed along the runway beam, the base caught on part of the hoist structure. This caused the LCP to tip over and fall from the lifting strops to the ground. All works were immediately stopped, pending a review of the arrangements.

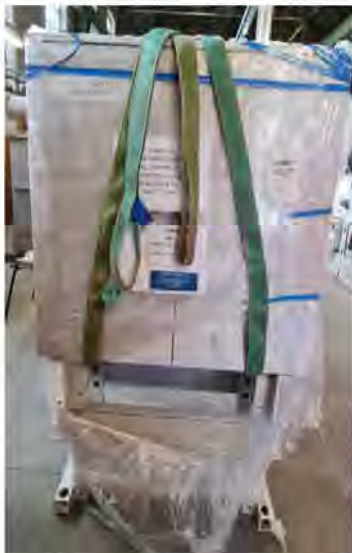
Image showing how the LCP was slung during the lifting operation

- There were no injuries as personnel were clear of the lifting area.
- The LCP was significantly damaged as it fell 2.8 metres onto the ground.
- The LCP has been quarantined pending return to the manufacturer for assessment.

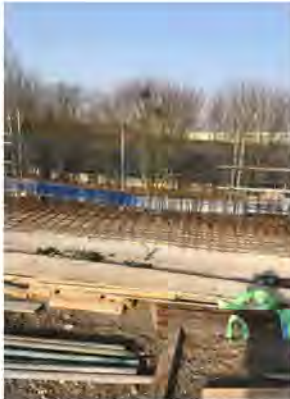
Section of scaffold type handrail removed and brickguard in place to allow anchor slab formwork installation.

Thankfully no persons were injured, and no damage or disruption was caused to road network. Damage was however caused to the front passenger tyre of the customer vehicle who drove over the scaffold tube.

1. Review task documentation for activities involving works at height/lifting where there is potential for falling material/objects.
2. During review ensure installation of drop zones has been incorporated to ensure no personnel access below operations; and consider use of scaffold fan structures to prevent any objects that may accidentally fall from the structure causing damage or injury to property or persons on the ground.
3. Review task documentation for activities where there is potential for materials to enter live carriageways.

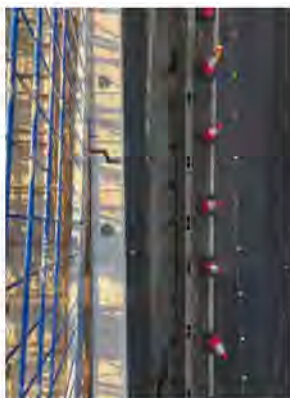
View to live carriageway below

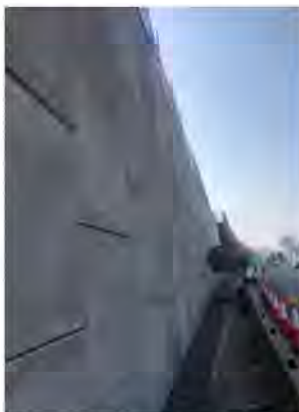
View of REW to live carriageway

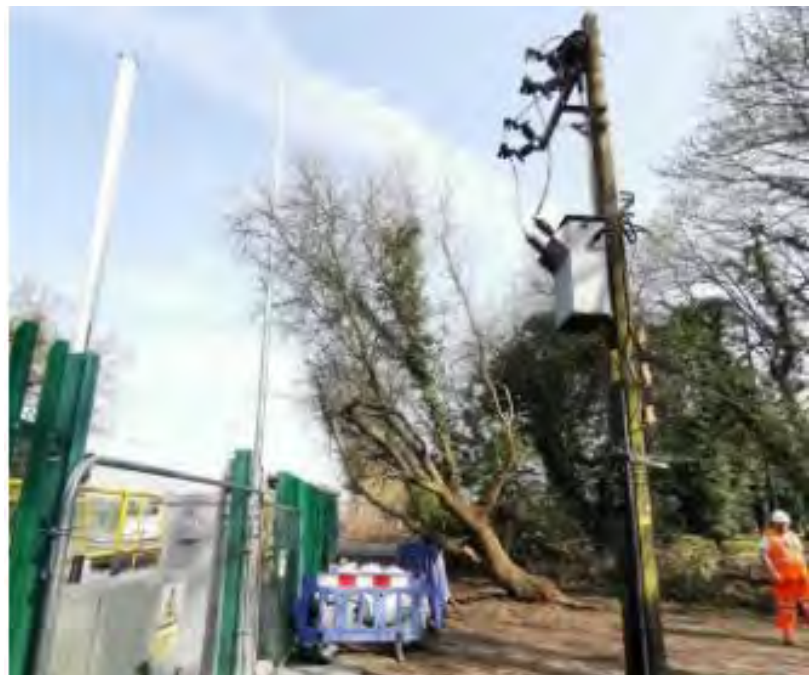
Before the work began, the project team spotted a bird’s nest, which they could not easily access to confirm if it was in use. However, in consultation with the Southern Environment Team, the project team was able to use a drone piloted by a trained Network Rail Construction Manager to check the nest, resulting in safety, time and cost benefits.

The initial options discussed for the works included a team member climbing the tree. Ultimately it was decided hiring a Mobile Elevated Work Platform (MEWP) to investigate the nest would be the most suitable option however, there was drone pilot on hand to help. Not only did this save the team money it also saved time on planning and procurement and most importantly they did not need to have anyone working at height.

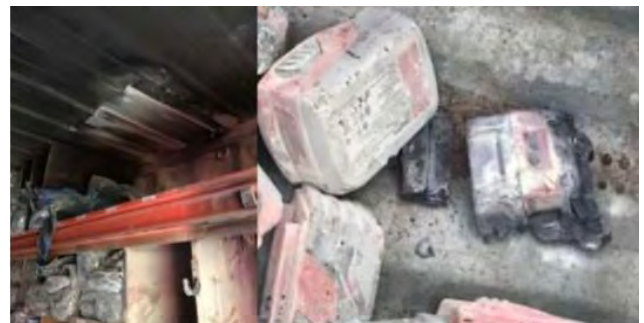
Network Rail, Southern region Capital Delivery have shared the importance of correctly storing and maintaining lithium batteries, after a Lithium-Ion battery that was being stored on a shelving unit underwent a catastrophic and spontaneous failure. This resulted in a runaway exothermic reaction, destructing battery. This caused molten metal sparks to fly onto nearby combustible materials and surfaces, starting a fire.

- Always remove Lithium-Ion batteries from tools after use
- Regularly monitor when charging and remove from the charging unit as soon as fully charged
- Return any battery that appears to be defective to the manufacturer i.e. leaking fluid or requires unusually long charging
- Do not leave batteries exposed to direct rays from the sun, elevated temperatures, sparking or open flames. This can lead to explosions
- Keep batteries away from rain, moisture and liquids.

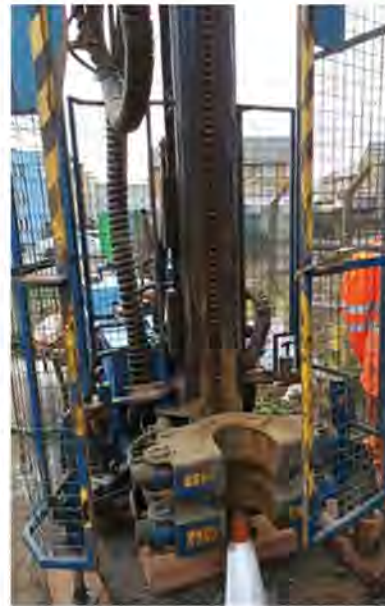
During a site investigation, the cage interlock on the rotary drilling rig was checked during a CDM-A site visit. When checked, it was found that each rig cage door could be opened approximately 10-12 inches before the interlock operated to stop the rotating parts of the rig, leaving an opening of 20-24 inches.

The failure of the interlock meant there was an increased potential of entanglement with the rotating parts of the drilling rig i.e. the 'danger zone'.

As the interlock was found to be faulty and there was not a valid inspection check sheet, works were stopped onsite. The drilling rig was not used until the faulty interlock had been rectified.

- The Principal Contractor must ensure that daily plant checks have been carried out prior to any plant being used onsite.
- Where any faults are found with plant prior to or during operation, then the equipment must be quarantined until the fault has been rectified.
- The operation of interlocks should be part of the daily checks and maintained in accordance with the manufacturer's instructions. As this is a key safety function for the drill rig.

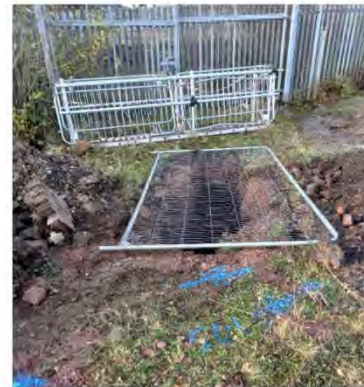
Photographs

- Lack of Discipline - A full CAT and Genny scan prior to starting work would have identified the presence and location of the 132kV cable.
- Capability – The purpose and use of the mobilisation checklist was not fully understood by the BBV Supervisor
- Leadership – BBV senior managers were not routinely visiting GI locations to verify that critical controls were being implemented.
- Leadership - Recommendations from a previous 132kV near miss had not been fully implemented.

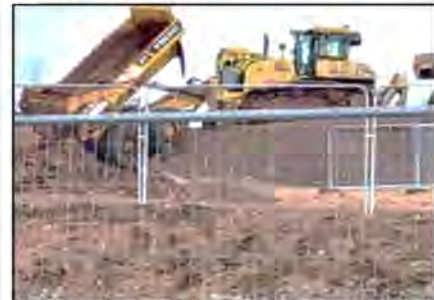
Photographs:

- Poor planning and supervision of the work area.
- The designated tipping area was flat level compacted ground, but the incident occurred on a 15–25-degree ramp with soft ground.
- The General Foreman had left site and handed over responsibility to the Foreman. Communication of the Safe System of Work was ineffective.
- The ADT was fitted with a tailgate due to its previous use to move slurry from another area. Material being transported at the time of the incident was very sticky clay, which jammed up against the tailgate when being tipped. This caused the weight at the back to lift the cab and then overturn.
- After the incident, the ADT continued to be used without BBV Plant Maintenance being contacted to check the vehicle thereafter.
- Poor decision and judgment by the Foreman to not fully communicate the incident to Senior Management.

- Poor instruction and lack of Supervision within the work area.
- Point of Work Risk Assessment did not fully identify key hazards. The Handover between the General Foreman and Foreman did not include a re-evaluation of the tipping area.
- Safe System of Work was not implemented at the time of the incident. – Poor communication between ADT Operator and Dozer Operator resulted in the ADT reversing and tipping on an incline with soft spots present.
- Poor configuration of the ADT which was fitted with a tailgate whilst handling wet sticky material.

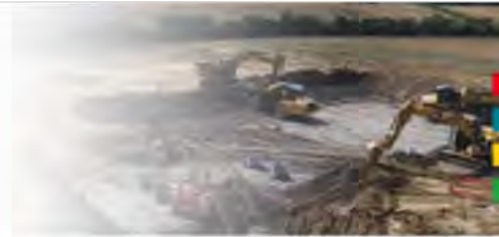
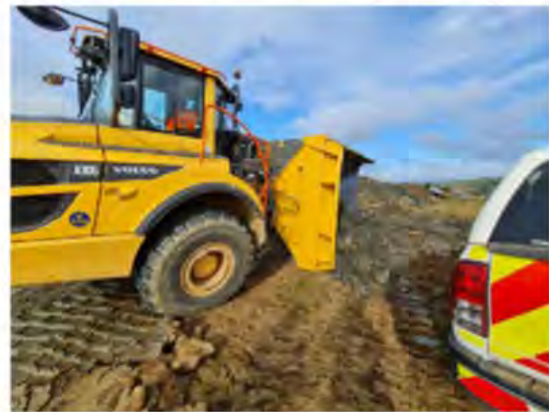
Greatworth to Southam

- The ground was firm and of good condition.
- ADT speed leading up to the incident was 3/4 MPH (confirmed by vehicle telematics)
- EKFB Fatigue standards had not been exceeded
- Nobody was injured in the incident
- The operation took place in a segregated, plant only, working zone

A briefing was held on site about the incident with checks undertaken for similar works in the area

Recovery plan implemented and the ADT successfully righted

- Ensure plant assessments on plant drivers/operators have been completed by a competent person and are available.
- Review the planned access/ egress routes for stockpiles and where possible eliminate the need for reversing.
- Ensure the edge bund is correctly constructed – compacted, at least ½ the height of the largest wheel.

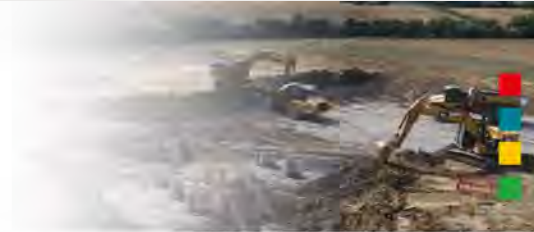
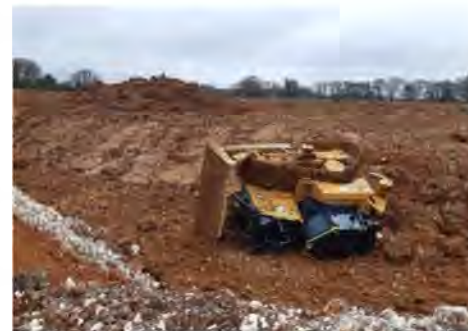
Great Missenden Compound, North Chilterns Area

A D6 dozer was reshaping a stockpile. While reversing, the machine got too close to the edge of the stockpile and the ground spalled, causing the dozer to overturn and land on its side. No injuries were sustained.

- There had been heavy rainfall the night before the incident
- The ground conditions on the stockpile were soft and appeared to be uncompacted
- The dozer was reshaping the stockpile while other earthworks operations had ceased
- The dozer fell backwards down the edge of the stockpile and came to rest on its side

- Driver and supervisors D&A tested – all returning negative results
- Works ceased across all delivery areas for the subcontractor
- Subcontractor remains stood down pending review and initial findings from investigation
- Planning for safe recovery of plant underway

- Review sequencing of works and communication of change on site
- Assess work area each day before commencing work
- Ensure temporary works designs are followed during the construction and maintenance of stockpiles
- Ensure regular inspections of stockpiles are undertaken
- Ensure earthworks operations are only carried out during suitable weather and ground conditions

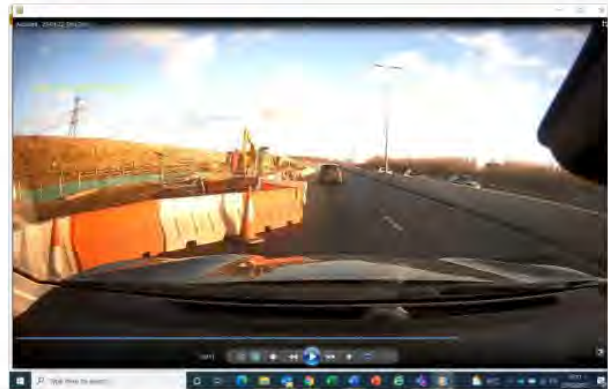
- The driver was unharmed, but some damage to their vehicle occurred.
- The investigation found the traffic barriers did not contain sufficient ballast (water) in accordance with the traffic barrier manufacturers guidance.

- It is unclear why the ballast was not at the required level; potential reasons could be evaporation or leakage.
- Only verbal communication was received that they had been filled correctly at deployment, and it is unclear whether subsequent checks had taken place.

- Discuss and review timescales for the monitoring of water levels within traffic barriers (specification states daily).
- Check manufacturer's guidance on fill levels and suitability for use in high winds.
- Critically examine emergency protocols when bad weather is forecast.
- Ensure that effective communication methods are in place with the Regional Operations Centre for emergency situations, to ensure a swift response to unsafe conditions takes place (including non working days).

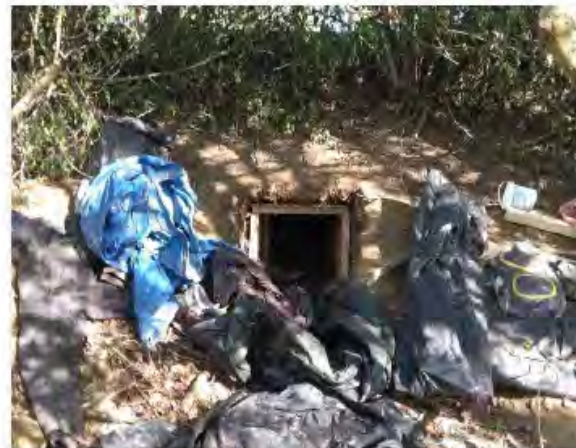
Protesters are attempting to conceal their tunnelling activity by using tarpaulins or caravans or other objects to screen the entrance excavations.

Even if the tunnel does not compromise the road surface, there are significant safety issues for those tunnelling, our customers, and staff. It is likely that this tactic will continue, with protesters targeting parts of the network as part of their ongoing strategy.

- Vigilance by staff and supply chain partners, and reporting any suspicious activity to the relevant Regional Operations Centre as a matter of urgency will allow the Police to respond and put a stop to tunnelling.
- Tunnelling can be identified by the presence of digging tools, caravans and other objects seemingly abandoned on the roadside, tarpaulins etc which may be used to conceal tunnelling.
- Any part of the SRN could be targeted, but those parts of the SRN close to refineries and oil storage depots are particularly at risk.
