SHEQ ALERT

| Reference number: | 012/2023 | Date 18/07/2023 |
| Title: | VRS Reversing Incident | |

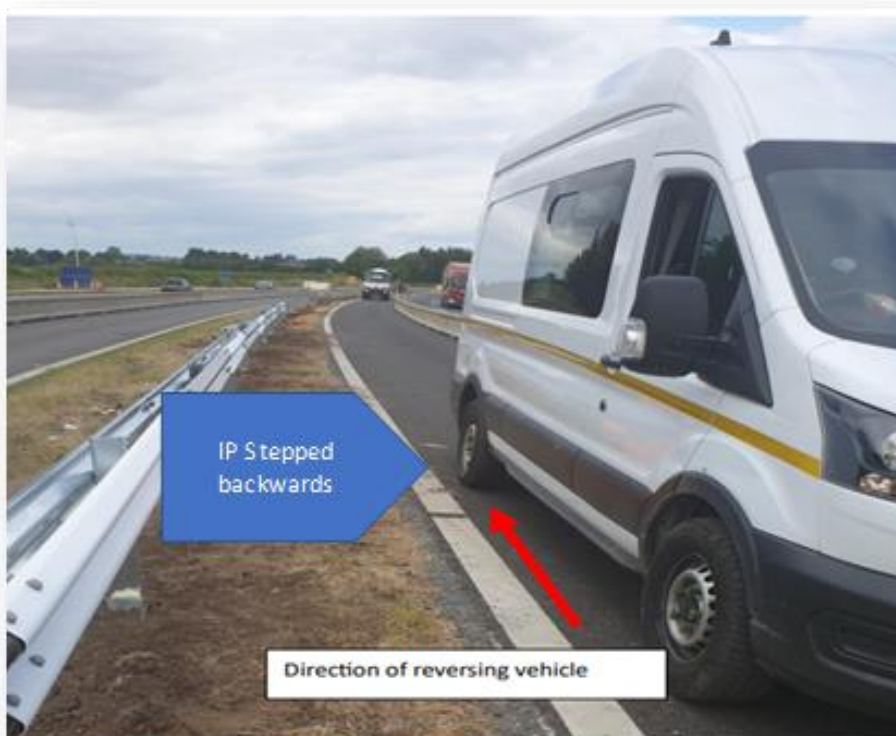
On Friday 23/06/23 at approximately 14:20pm, a VRS operative tightening post bolts on the A1M J56-58 renewal scheme stepped back to check the washer on the bolt he'd just tightened and was struck by a vehicle reversing in the works area. The VRS Operative (IP) sustained a broken leg and was taken to hospital for treatment.

- **Insufficient vehicle management planning** – Colas to ensure the planning of vehicle movements including prohibiting reversing are clearly defined and communicated to all Colleagues and Supply chain partners. All works vehicles to be designated a carriageway for parking. The opposite carriageway will remain free for access through site for concrete deliveries, muck away etc. Order in which vehicles enter site will be properly planned prior to leaving the site compound. Number of vehicles taken to site kept to absolute minimum. Reducing movements by ensuring all works vehicles to be loaded with correct equipment required for that shift prior to leaving the compound. Waste materials such as bolt boxes, packing etc to be cleared as they go rather than collect later. If changes to the plan are required these must be recorded and briefed to everyone on site before the change is implemented. In the event a reversing procedure with bankman is required any person(s) within the reversing area will be fully communicated with and stop work if there is any risk to personal injury.

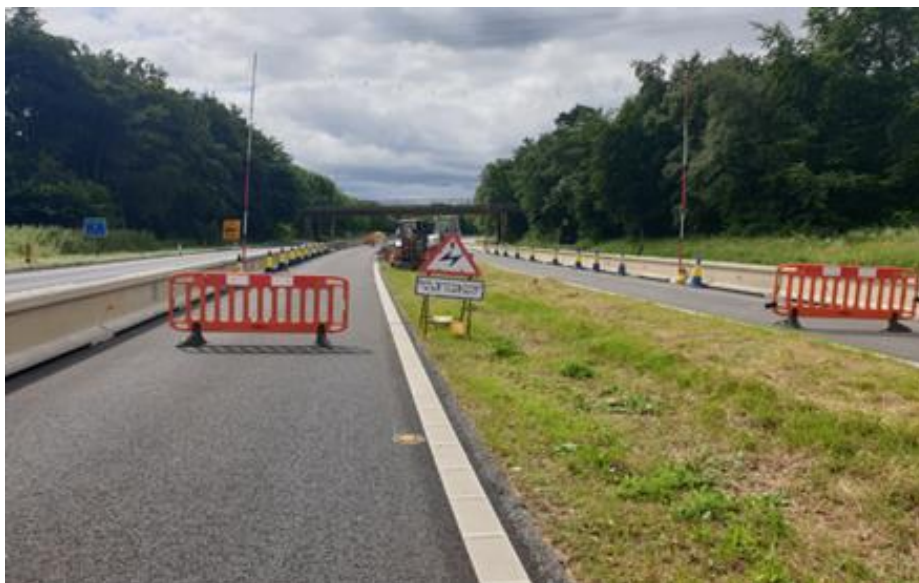
- **Plant person segregation** – Although other plant person segregation was included in the RAMS the movement of lorries and vans was not. Pedestrian barriers have been used to create exclusion zones where works are taking place. Only site operatives/banksmen will be permitted to allow access beyond the barrier to prevent unauthorised vehicles and personnel in work area. Lorries are required to stop at the barrier and wait for access and that will be granted when personnel have moved out of the way.
