Hello and welcome to our April STOP Think! Cascade Briefing. As I write this introduction, I am just working through our year-end review for what has been probably the most challenging year in our history!

## Unsafe Work at Height – Sudbury Hill

(STOP Think! Moment No. 137 - 03 March 2021)

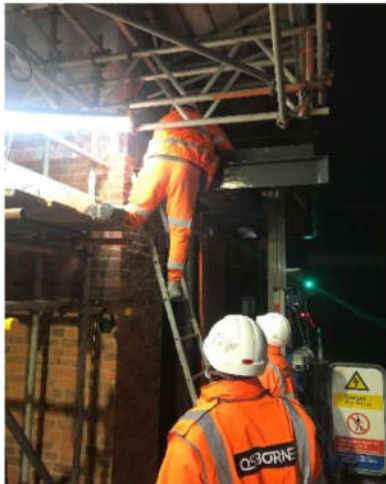
Osborne supervisor in the process of stopping the operation at the time the photo was taken

On 03/03/21 on one of our LUL projects, operatives working for an Osborne supplier were observed undertaking a task that involved work at height to install a reinforced steel joist to a newly constructed lift canopy on the station platform.

The operatives were seen working unsafely at height. The works were stopped and the ladders removed. The issue was raised as a close call. Following the intervention, the correct access equipment was obtained. It was subsequently noted and raised as another close call that the mobile tower in use had not been assembled correctly as it did not have toe boards installed.

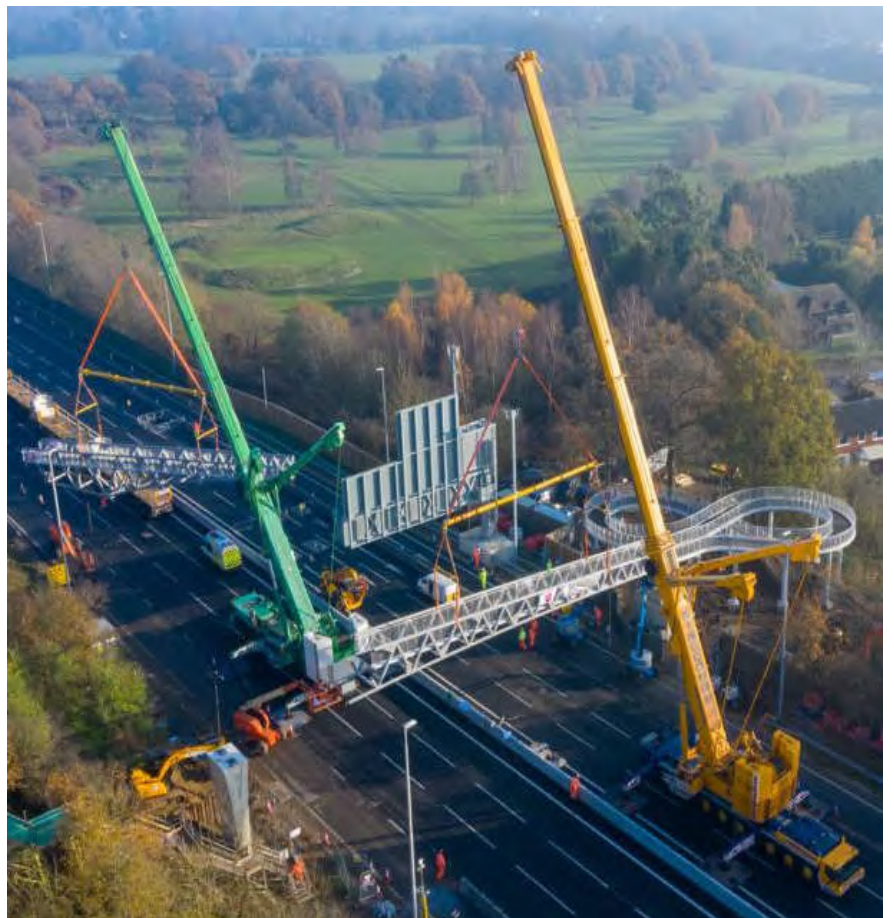
The 53 tonnes deck was designed to be transported and installed in two parts, coming all the way from Scunthorpe to be lifted into position using a precision tandem crane operation to support the two halves of the deck while they were connected.

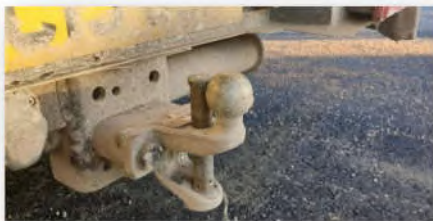
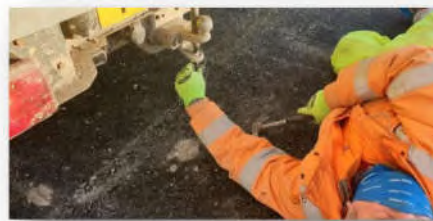
A Ganger and Operative had experienced issues inserting the towing pin when hitching the trailer. The holes on the towing hitch and mount were slightly misaligned, so a claw hammer had been used to tap the pin into place.

The force used to insert the pin meant that it couldn't be removed by hand, so the claw hammer was again used when unhitching the trailer. The operative used the hammer in an upwards motion driving a 150mm bolt through the bottom hitch hole to push the pin out, after a few strikes the pin started to move slowly upwards. As the pin released the operative felt a sudden pain in his left index finger (the hand holding the bolt).

When the operative removed his glove he realized that the flesh had been stripped from the tip of his index finger exposing the bone (distal phalanx). His finger had either been struck by the claw hammer directly or crushed between the bolt head and towing hitch (the Injured party was unable to determine exact cause of the injury)

- The misalignment was not considered by the team to be significant so a claw hammer and bolt were used to insert/ remove the towing pin (the pin should not have needed additional force to be applied)
- The misalignment (possibly caused by the hitch being previously knocked) should have been logged and the vehicle quarantined from towing activities.

Also remember that correctly inspecting vehicles (including its accessories), reporting defects immediately and restricting vehicle use are all fundamental controls essential in preventing towing related incidents.

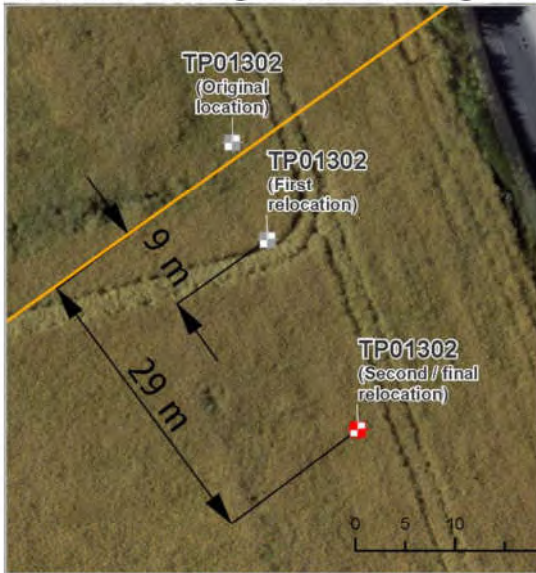
### High Pressure Gas Main Strike

On the morning of the 2<sup>nd</sup> November a mechanically excavated trial pit was programmed to commence at TP01302.

Following the issue of the design to Perfect Circle (AECOM JV), it was identified within AECOM's GIS system as directly over a high-pressure gas main, which was a clear failure of the CDM 2015 design process.

The sub-contractor set out the location of TP01302 using a digital GPS device, however the data within this device had not been updated since May 2020 and as a result TP01302 was set out in its original location, directly over the high-pressure gas main. The engineer also failed to check the information within

Following procedure, the area around the works area is required to be checked for signs of furniture which could suggest the presence of services and a CAT & Genny scan of the works area undertaken. Both requirements were not completed to a suitable standard, missing the opportunity to identify a high-pressure gas marker board 10m away or the 500mm cast iron service below the position.

While the root cause of this incident is a failure of the non-AECOM design team to eliminate the risk through design. The poor management of data within digital devices was a significant underlying cause.

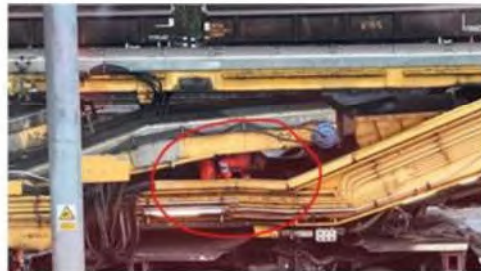
Image shows the operative working inside the BCS system.

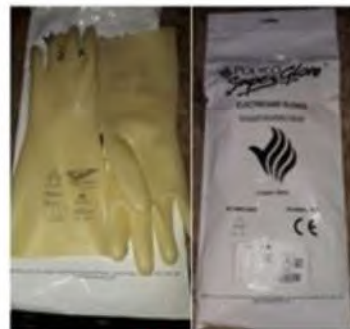
POLYCO 'SuperGlove' electricians' gloves (shown above right) have been used by Network Rail in various sizes for many years, rated for both 500V AC and 1000V AC resistance.

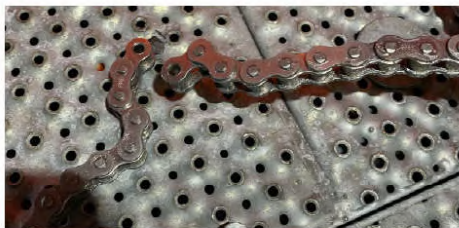
Photo: Failed chain

During a night shift installation of a CCTV track-bracket mounted on top of a MS4 gantry, testing was being undertaken on the winch system. During the test, the winch chain failed causing the camera mount (10kg approx.) to fall 4m to the base of the CCTV mast. No injuries occurred but there was significant potential for harm to the installation team. Track brackets and chains of this design are widely used on the UK motorway network, yet no other incidents of this type have occurred.

- All existing CCTV Materials / equipment should be fully checked for compliance.
- Use the POWRA to check that all the hazards have been identified.
- Consider 'Poka-Yoke' to avoid errors / i.e. mistake-proofing/build in safety measures.

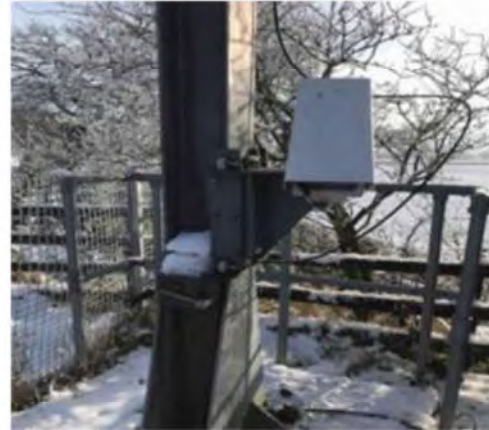
Location: Rigton CCTV level crossing

On 15th January 2021, a CCTV camera platform fell down a mast, narrowly avoiding injury to a signalling technician at Rigton CCTV level crossing.

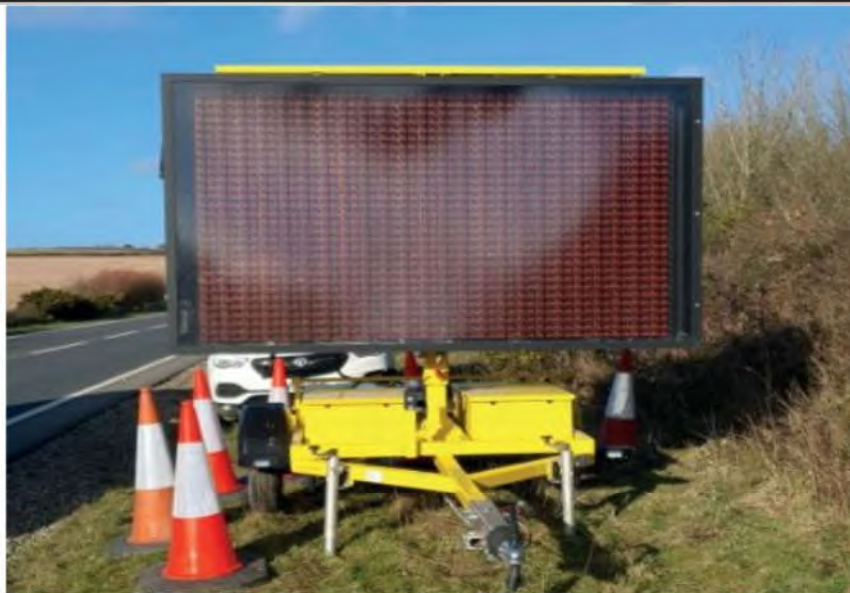
Mobile VMS Wheel incident 24/02/2021

A recent Significant Near Miss incident occurred on the A30 Chiverton to Carland Cross project in February. The nearside wheel of a Variable Message Sign (VMS) fell off and travelled across the carriageway into oncoming live traffic whilst the unit was being towed.

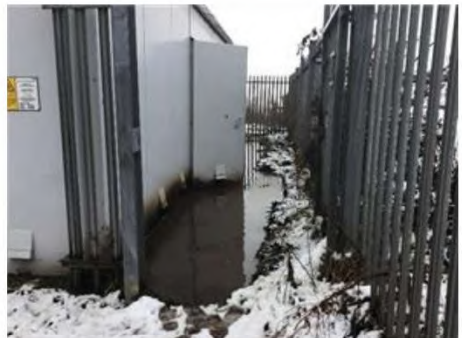
Location: Carstairs TSC, Scotland Region

In a recent incident in Scotland Region, significant flooding was discovered in and around a 25kV Track Sectioning Cabin (TSC) at Carstairs. Pools of water inside and outside the cabin are also believed to extend underneath the building's false floor creating damp conditions and potential corrosion of the traction power equipment within. The site dehumidifier was out of service and several defective heaters were found.
