July 2020 - STOP Think!

Introduction

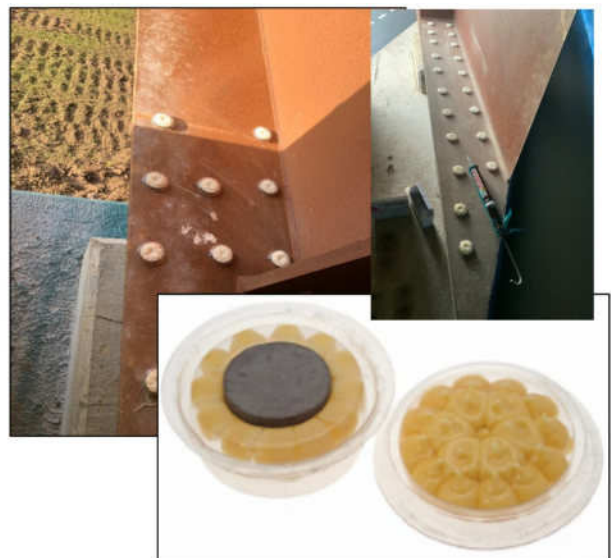
“Bird Free” keeps birds of all varieties from all structures without harming them by altering their behaviour, not by acting as a physical barrier. Birds see ultraviolet light, so to them, “Bird Free” looks like fire as demonstrated below;

On the A14 Cambridge to Huntingdon Improvement Scheme there are many structures where nesting birds are causing corrosion of the bearings caused by the ammonia and acids found in their faeces.

Due to difficulties with the installation of bird screen mesh, an alternative preventive method was sought by the A14 Integrated Development Team. Their proposal was to install "Bird Free" at 20cm centres.

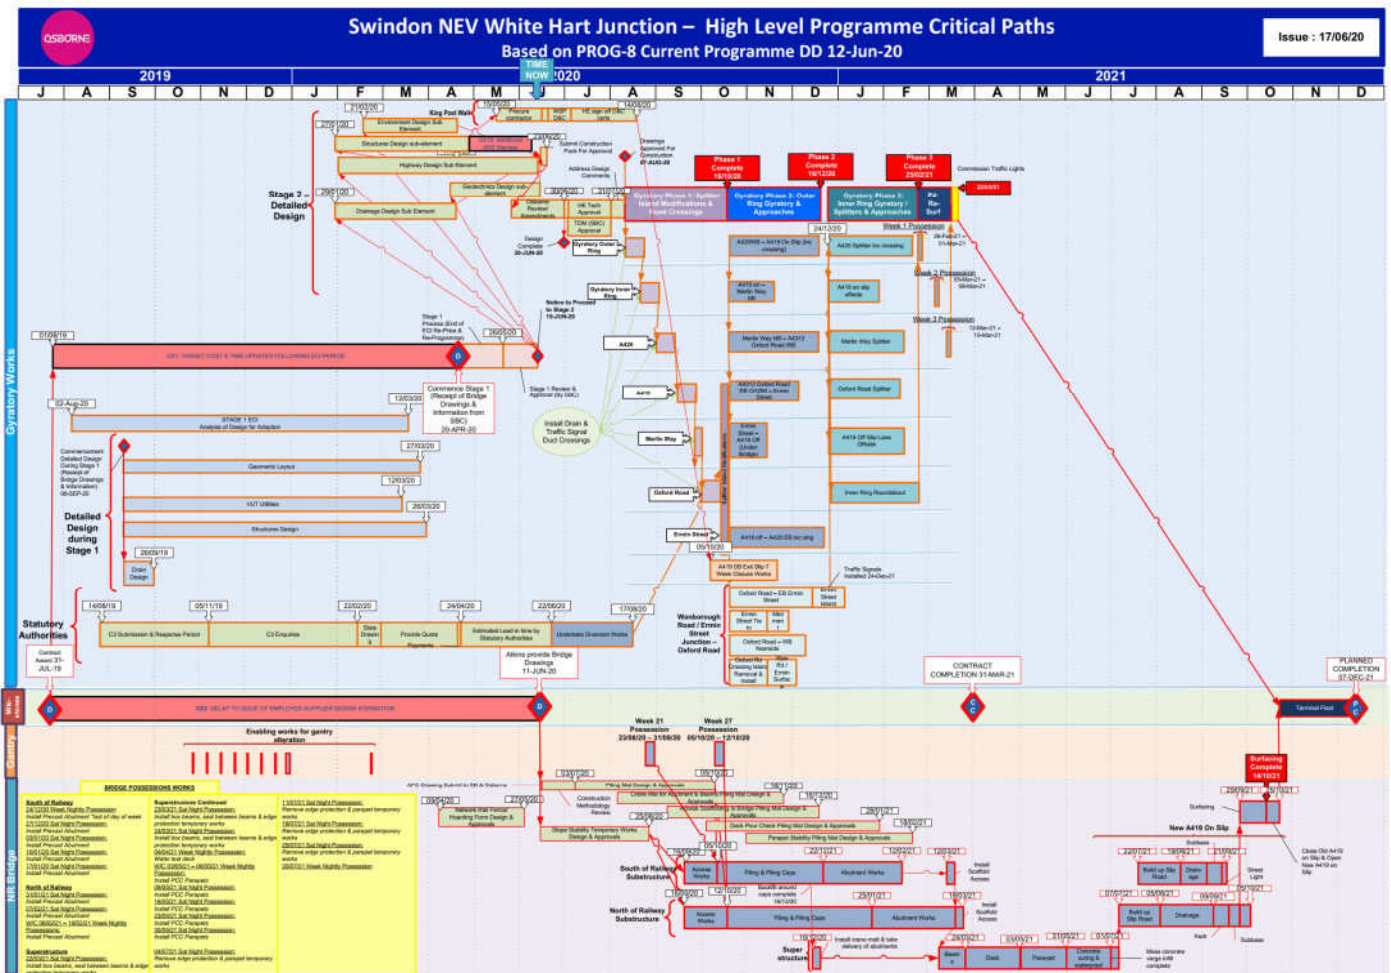
This high level visualisation of the programme can be converted to a pdf. It is therefore particularly useful to share with our customer and is proving to be a great tool for understanding at a glance the high level Progress of the scheme and the complex interconnectivity between the numerous deliverables.

With the works currently planned to complete at the end of next year, the full Primavera P6 programme, with its hundreds of work activities is not only rather large – our customer does not have the software to open and view it electronically. Working with large paper printouts is not only unsustainable, it is impractical for all, therefore working with our specialist programme partner MBM Consulting, the site team have developed a “Programme on a Page”.

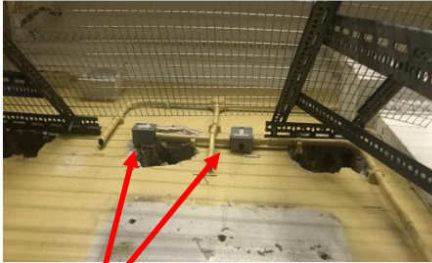
2 electrical spurs still in-situ. The circuit had been switched off previously by LUL contractor at the distribution board, labelled but not locked off.

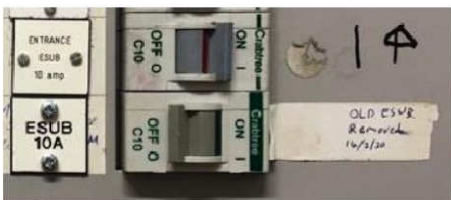
Circuit switched off & labelled at the distribution board, but not locked

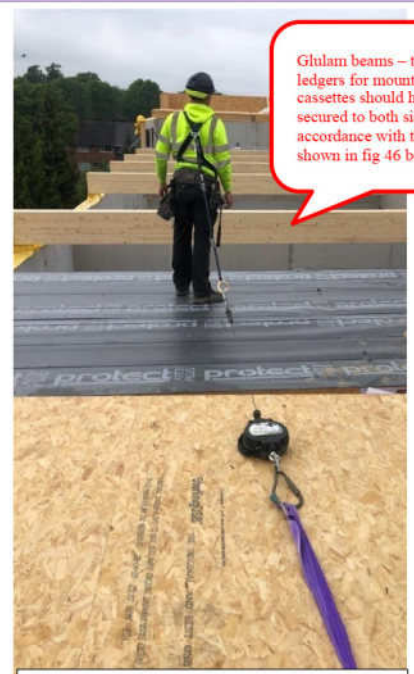
Simulation of fall arrest set up.

Overview:
At approximately 15:10 on 11/06/20 an Innovare sub-contractor operative fell through a roof cassette at the Turves Green site near Birmingham. The individual was wearing all the correct PPE including a full body harness and was safely clipped on to a secure anchor point via a retractable fall arrest block.

The operative dropped approximately 2m before his fall arrest equipment deployed, the broken cassette fell about 8m to the ground below, a full exclusion zone was in place and no injuries were sustained.

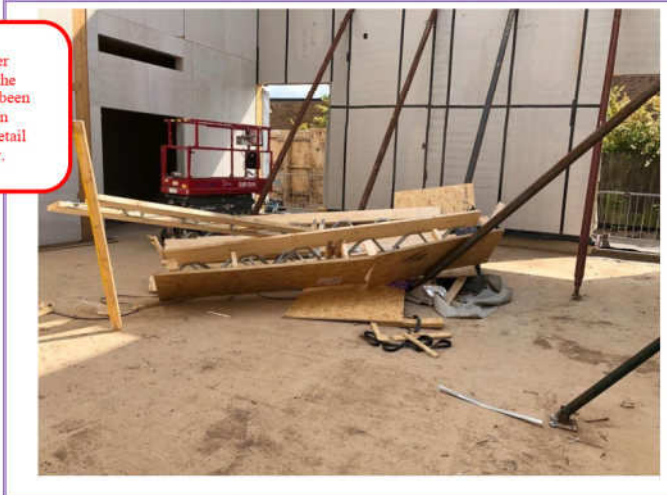
Glulam beams – timber ledgers for mounting the cassettes should have been secured to both sides in accordance with the detail shown in fig 46 below.

- Preliminary findings from the investigation have established the following:
1. Timber ledgers should have been fixed to the glulam beams to support the cassettes; they were not.
 2. The cassette was only supported by the 18mm OSB deck resting directly on the glulams which collapsed when the Operative walked across it.
 3. The emergency rescue plan was initiated promptly and effectively.

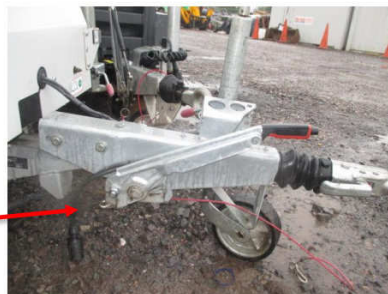
Secondary control was not in full contact with the interlock.

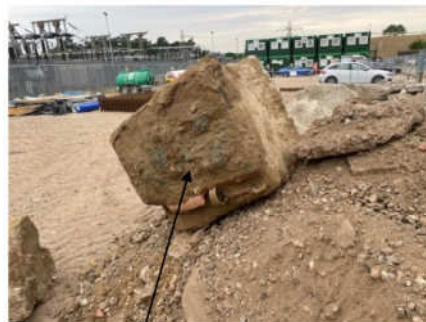
The approximate position of the concrete block is shown by the red outline on the picture to the right.

Concrete block (after removal)
Approx position prior to removal

To make the area safe the concrete block needed to continue to be moved. Once the block was safely removed it could be seen that there was damage to one of the cables (the outer sheath of a 15mm cable).

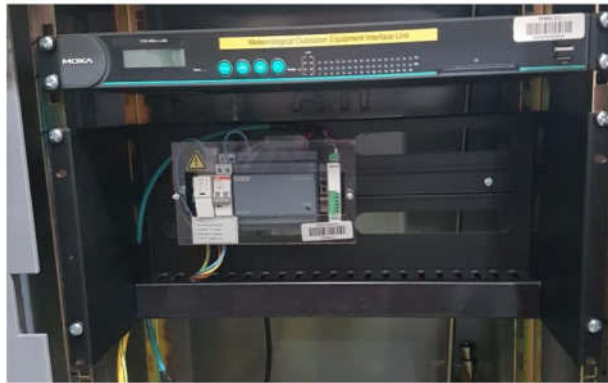
Issues regarding the Vaisala Weather Station Equipment Rack and its non-compliance with BS7671:2018 Requirements for Electrical Installations
