June 2020 - STOP Think!

## Victoria Station Fire (STOP Think! Moment No. 104, 02 June 2020)

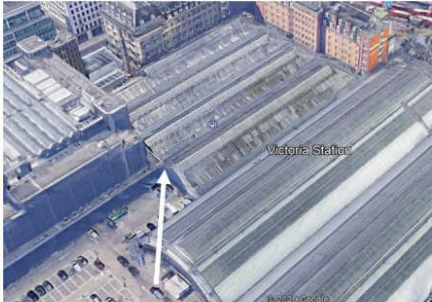
View of roof – arrow indicates location of fire

1. The application of direct heat to Bostik flash band tape to get the bitumen "sticky" is bad practice.
2. All products must be installed/used as recommended by manufacturers in their product data sheets.
3. All operatives must have some form of basic fire awareness training. A Toolbox Talk can be used as a stop gap until such training can be arranged by suppliers for their employees.
4. Hot work permits must be issued in hard paper format as required by Osborne fire safety procedures and guidance.

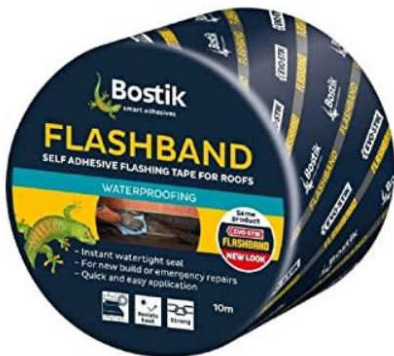
Bostik flash band tape

The practice of applying heat to the product with a brazing torch is one that may have been widely adopted by artisans using it to carry out repairs but is not endorsed by the manufacturer.

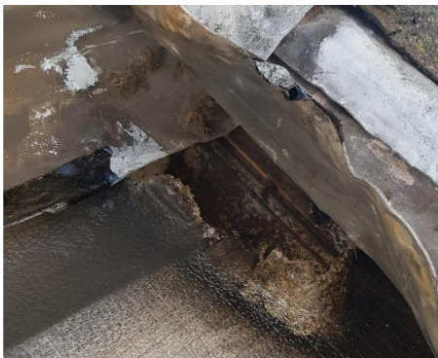
Fire damage to Polycarbonate

A supplier was working on the refurbishment of the roof at Victoria Station and caused a fire as a result of hot work.

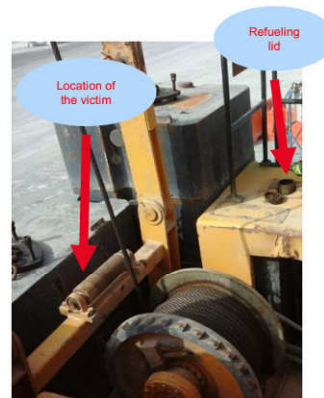
2 Position of the victim during the accident

- Ensure proper identification hazards for routine operations
- Ensure sufficient rear view mirrors & winch camera to check back side of machines
- Implement proper guards, barriers and working platform (collective protection) to all cranes and rigs
- Ensure a radio communication to for all operations (including routine activities)
- Update the Lock Out / tag Out procedure, (only one key to start the machine and open the fuel hatch / no operator in the cabin)
- Perform a Management of Change training. Each department / site management team to notify the organization and the HSE department regarding new changes that could affect the current organization
- Accident debriefing must be conducted for all personnel at all sites

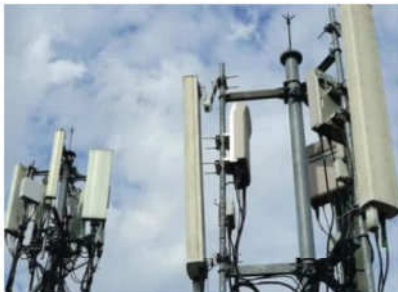
Some of these posters have blades or other 'sharps' placed behind them, in a deliberate attempt to injure anyone who attempts to remove them.

The following poster is one example of those seen on new 5G masts - however these are not the only ones being used.

- Please make sure ALL of your site staff who may be exposed to this issue are made aware and are vigilant to ensure they or anyone else isn't put at risk.
- If any posters or stickers with 'anti-5G' messages are found stuck to any monitoring stations, traffic signals post or cabinets, lighting columns, feeder pillars, etc., treat them with caution and do not attempt to remove them.
- If you suspect sharps have been placed behind the poster report its location immediately to your Supervisor. That way you can ensure it is collected and disposed of correctly by a competent person with the appropriate equipment.
- If you are accidentally injured by a blade / needle then report it immediately, clean and cover the area and seek medical attention.

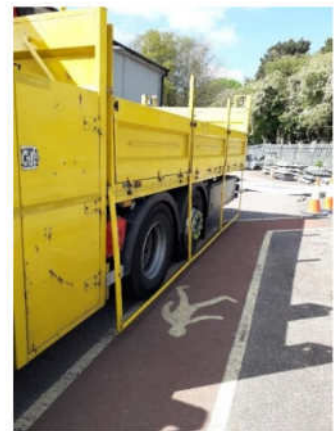
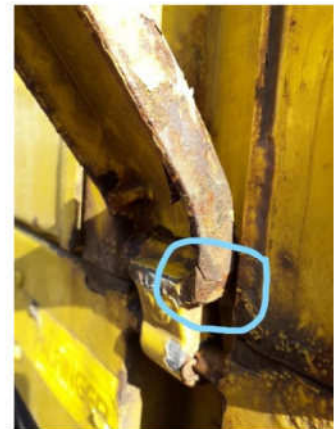
The IP reported whilst unloading the barrier rig, that he went to lower one of the side panels and the edge protection safety handrail fell hitting his head (hitting his safety helmet), shoulder and right side. Four days following the incident the IP attended hospital, after which the IP alleged, he had sustained broken ribs resulting in a self-certified over 7-day injury.

The investigation found a reported defect (as shown opposite) that required a change in working practices whilst awaiting repair and rectification.

- Reiterating the importance of reporting incidents within 24 hours in line with company procedure.
- Operational changes to be formally recorded in writing i.e. 5 minutes on safety briefing
- Lone working is not permitted in depots without a specific lone worker risk assessment to determine permitted activities.

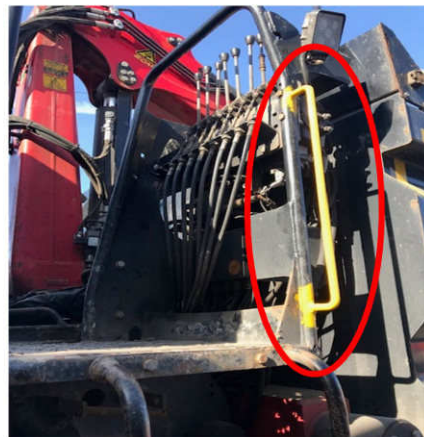
The highlighted area shows the new handrail for better access

This has now been rectified by installing an additional handle on the outside of the rail so the driver can use this instead of having to reach over the crane controls to gain access to the working platform.

All vehicles of the same design should be checked so that drivers have easy access to the working platform to avoid another incident of this nature from happening again, and please reinforce to drivers the importance of defect reporting and their legal duties for carrying out defect checks.

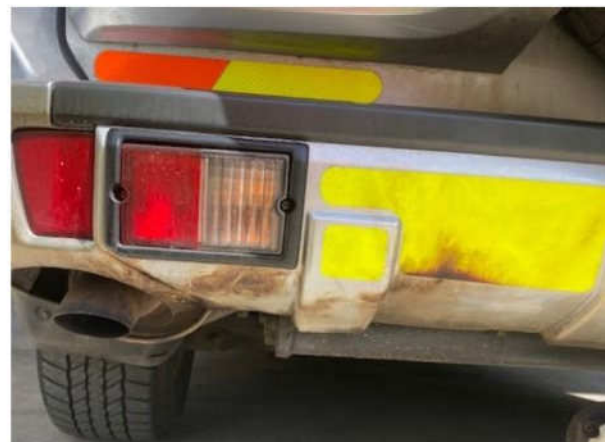
- Whilst a Traffic officer vehicle (TOV) was parked at a park up point (PUP) on the M61, The Traffic Officer (TO) noticed that the TOV started to raise its Revs, this is a natural action that the car does known as "re-gen". Just after this stopped the TO then smelt something burning and looking in the wing mirrors noticed smoke coming from the rear of the car. The TO immediately moved the car forward and got out and saw smouldering of the grass to the rear of where the TOV was parked.

- The TO extinguished the smouldering grass and on looking at the rear of the TOV noticed there were a number of scorch marks on the paintwork.
- Following the incident, the TOV was inspected at RIVUS fleet Warrington to ensure there were no inherent faults and there was no structural or mechanical damage to the TOV.

- On speaking to the mechanic undertaking the inspection we were informed the re-gen process can produce heat of up to 600 degrees +.
- The DPF Regeneration process is the process of **removing soot built up over time from the diesel particulate filter**. It is done in one of three modes; passive, parked, or active during which very high temperatures are reached.

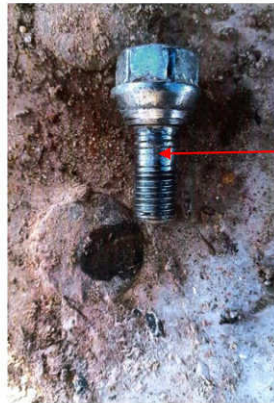
- The wheel studs were loose, which was not identified by the driver during his visual inspection

Wheel stud with 50% of thread damaged

- A fitter visited site a week before and identified that the wheel nuts were loose and did not tighten them.
- The quality of the walk round visual inspection was inadequate
- The driver did not have the tools to physically check the wheel stud torque settings

- Coloured wheel stud indicator alignment should not be used as sole confirmation that the wheel studs are all securely held in place.
- Checking wheels studs for the correct torque settings is critical to the safety of the equipment when towed.
- As a result, a more detailed trailer pre-start checklist has been introduced across Balfour Beatty.

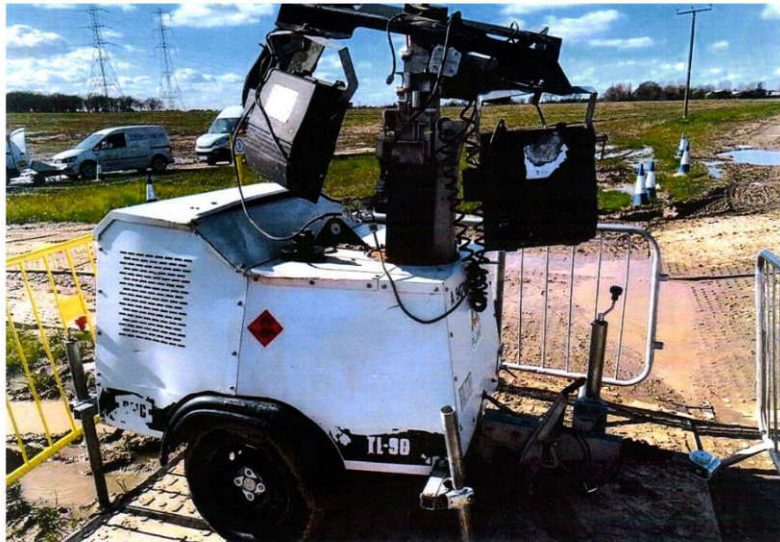
Lighting tower after the incident

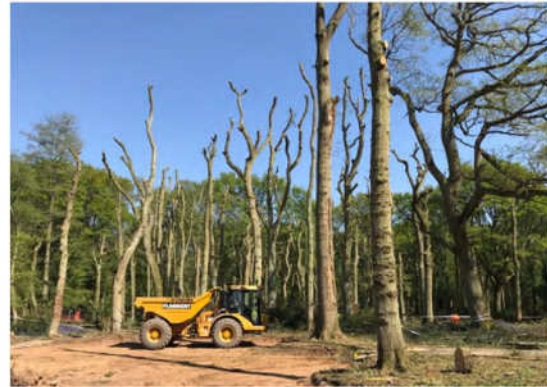
Two trees were identified as having bat potential and required further assessment prior to felling. Due to the proximity of WPD assets the trees were to be felled by a 3<sup>rd</sup> party utility contractor. The requirement for the 3<sup>rd</sup> party contractor to be supervised by an Accredited Agent was not communicated to the contractor, leading to the trees being felled without supervision.

Tree incorrectly de-crowned
