May 2021 - STOP Think!

Unsafe Work at Height

(STOP Think! Moment No. 140 - 14 April 2021)

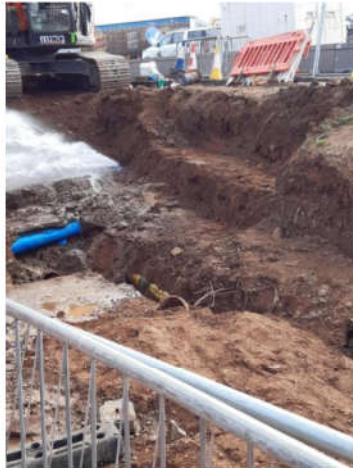
Damaged pipe releasing water

At approximately 08:15 on Friday 16th April 2021 a 300mm dia watermain was struck by an Osborne supplier's 20t 360 excavator. This occurred while undertaking operations to install a new drainage run and chamber location. It caused damage to the pipe and a significant water release.

Work was stopped, the service owner was contacted to conduct repair and investigation was undertaken.

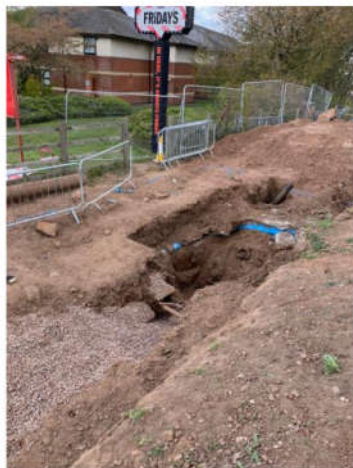
Previous Vacuum Excavation works undertaken to expose chamber location (Old watermain shown)

Vacuum excavation had previously been undertaken to expose services around the new drainage chamber location, but this did not expose the subsequently damaged watermain location. The services were marked on the ground, a trial hole had been undertaken previously adjacent to existing drainage run (which new drainage run would follow) to identify watermain location.

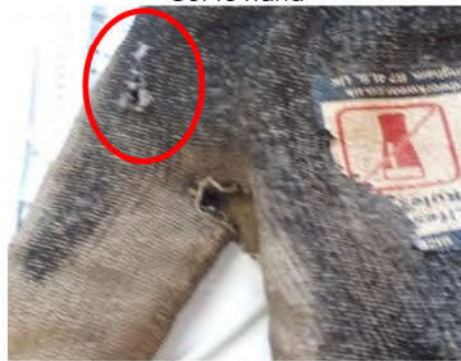
Cut to hand

Damage to glove - circled

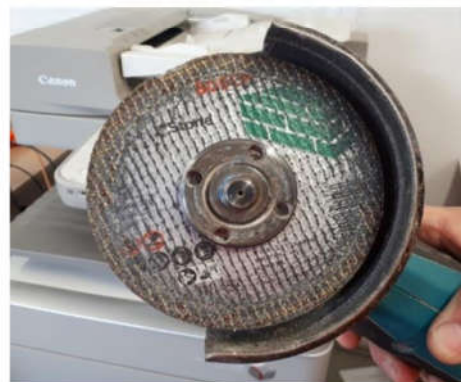
4" hand grinder which was used – note, stone blade fitted

A supplier's operative was put to work by his site manager and asked to add some extra metal sheeting to gabion baskets as some had been damaged by a machine. The sheet was initially attached the wrong way round and as a result the 'hog' rings needed to be cut to release and replace the sheets. The operative used a 4" cordless angle grinder for the task. The grinder was fitted with a stone blade not a metal blade. The grinder slipped and cut the operative's left hand.

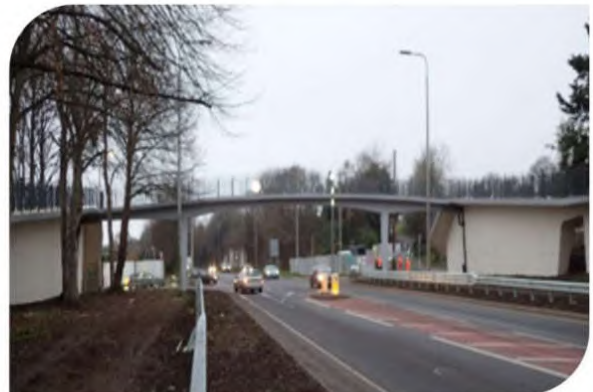
Markyate Footbridge 2020

Attention to detail in the WSP-Arup design has improved the durability and performance of the reinforced concrete structure, offering a low-carbon solution whilst maintaining heritage and responding to community aspirations.

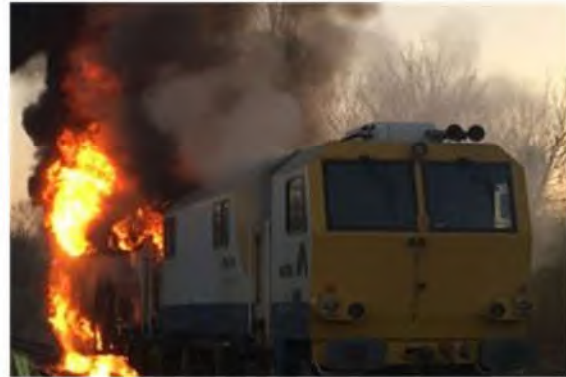
At 05:29 on 23rd April 2021, a Matissa B41 Tamper suffered a major engine compartment fire causing disruption to train services between Orpington and Sevenoaks. The line was blocked and an Emergency Switch Off (ESO) was implemented to enable the Fire Brigade to attend the scene. Thankfully there were no injuries as a result of this incident.

Whilst it is too early to identify the exact cause of the fire there are some similarities to an engine compartment fire that occurred on another B41 Tamper around 3 years ago. The fire risk is not restricted to Matissa B41 Tampers, the potential exists for any item of rolling stock or On-Track Machine with an enclosed engine room.

- Are maintenance regimes adequate to address the potential fire risk.
- Are regular inspections carried out to check the condition, security and integrity of all electrical connections in engine rooms.
- Are regular checks carried out on all hydraulic hoses in engine rooms.
- Are all hoses and electric cables routed away from potential risk areas whenever possible.
- Are all hose leaks in engine rooms addressed as soon as they are identified.
- Where fitted, is the fire suppression system tested on a regular basis.
- Are all sources of high heat which could cause combustion clean from fluids/debris such as engine manifolds and turbo pipe exhaust outlets.

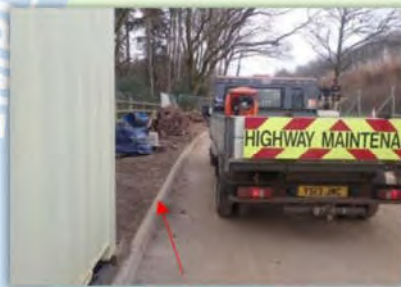
On Monday 22nd March the Injured Person (IP) had parked their van within a closed layby, upon exiting they walked towards the site storage container which was placed on the verge. Upon stepping onto the verge, the IP tripped on the kerb and landed on his right hand, the IP was immediately taken to the local A&E where they received an x-ray and a diagnosis of a hairline fracture to their wrist and a broken thumb. The IP has returned to light duties as of 30th March.

The investigation found that the IP had suffered from a momentary lapse in spatial awareness, but other potential contributory factors were considered which are discussion points for other sites.

- Housekeeping – The site itself had a good level of housekeeping at the time of the incident and looking back through site inspection history had a good level throughout the duration of the project.
- Risk Assessment – The site team had identified the risk of slips, trips and falls and appropriate control measures had been followed, going above and beyond in the woodland area by installing rubber matting to reduce the likelihood of an incident.
- COVID-19 Vaccination – The IP had received their COVID-19 Vaccination on the Saturday prior to the incident, although they were not feeling any effects from the vaccination, individuals have been reacting differently and this could be a potential factor for others.

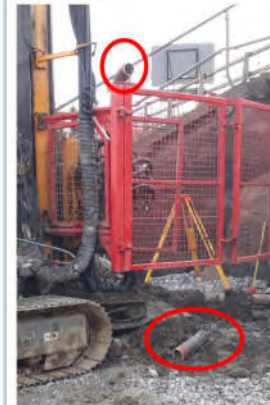
- During the installation of the very first pile, the section of steel pipe that connects the concrete supply line into the top of the auger failed.
- The supply line, laden with concrete, subsequently fell 8m to the ground.
- Fortunately, the supply line fell away from the rig operator who was stood adjacent to the auger

Swan neck arrangement of pipe that failed

- Inspect all fabricated sections of concrete supply pipe sections for signs of repair / poor welds
- Contact owner of piling rig and ask them to confirm what inspection / testing is done on such sections
- More information to follow once investigation is concluded

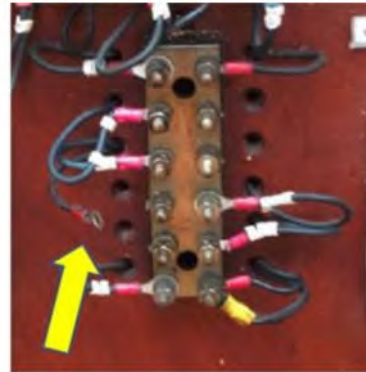
On 23rd February 2021 an engineering assurance inspection discovered an uninsulated wire had been left in situ for 9 months following internal wire renewals conducted by Network Rail.

It was found that wires were not appropriately recovered or sleeved following the work. It was also noted the signalling diagrams were missing from the location case 5/6A.

The incident follows three similar signal testing irregularities in the last 18 months on the NW&C Region and follows a wider national trend. As a result, the following discussion points are recommended:

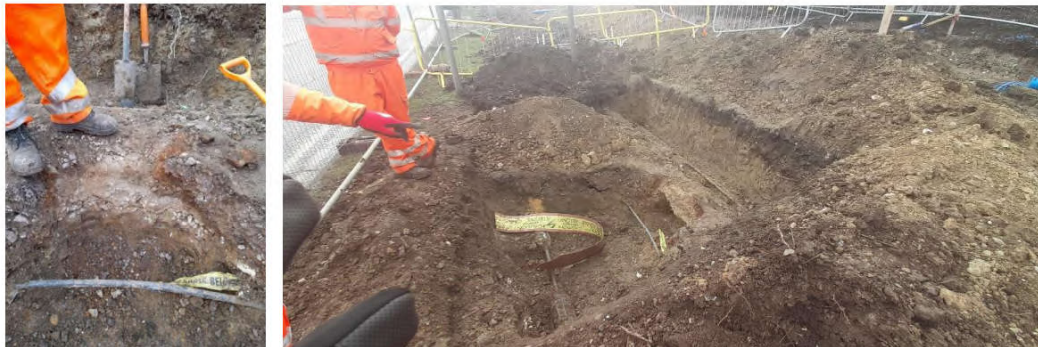
Whilst undertaking trial holes to enable UKPN to make connections of two known power cables in the area, an operative using insulated hand tools came into contact with a low voltage street lighting cable, damaging the outer sheath of the cable.

No one was injured in the incident, the operatives were wearing full flame retardant PPE and there was no arcing, sparks or smoke. The cable was not energised at the time of the damage, there was no loss of power and the streetlights were operational in the evening.

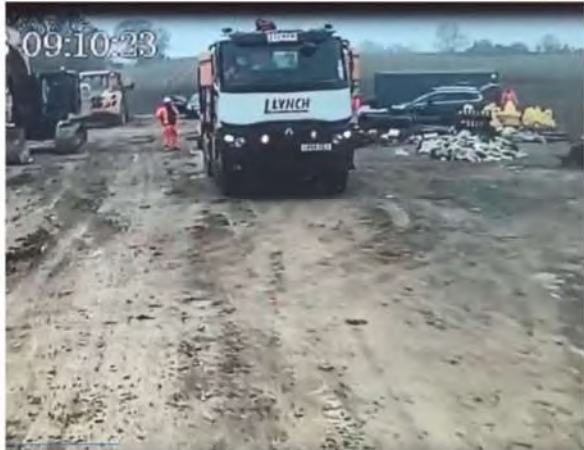
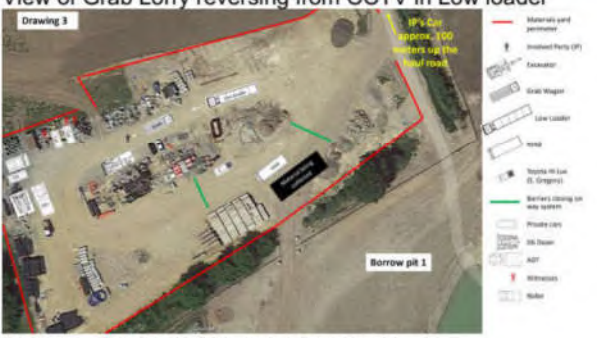
| Details of Incident: | Photos: |
|---|--|
| <p>The Incident</p> <p>At approximately 09:10 hours on the 3rd March 2021, an IP (Involved Party) was leaving the materials storage yard in order to relocate to a new working area approximately 7 miles away. As the IP was proceeding, on foot, to their personal vehicle (approximately 100 m away) they positioned themselves behind a stationary grab lorry.</p> <p>The IP's attention was momentarily diverted and at the same moment the grab lorry began to reverse. As the IP turned their attention back to the lorry, it was sufficiently close enough to the IP that they had to take evasive action.</p> <p>Although shocked the IP did not require or seek first aid and there are no reported injuries.</p> <p>On the day of the incident there were multiple activities being carried out, independently of each other, within the materials storage yard area.</p> <ul style="list-style-type: none"> - Team demobilising and moving to new site. - Ongoing Low Loader activities (Transportation of 6no. pieces of plant to new site approx. 7 miles away) - Hiab operations - Grab movements <p>There were three Black Hat Supervisors in the area at / or prior to the incident occurring.</p> <p>A full Investigation has been completed</p> | <p>View of Grab Lorry reversing from CCTV in Low loader</p> <p>Diagram of layout of Material Storage Yard</p> |

| Details of Incident: | Photos: |
|---|--|
| <ul style="list-style-type: none"> ➢ Incident was immediately notified. ➢ Positive communication and action between A14, Walters & Lynch ➢ Remote storage yard closed and all material moved to main compound where there is a permanent vehicle marshal | <ul style="list-style-type: none"> ➢ As the profile of a contract changes e.g. through demobilisation, there is a need to carry out a thorough, documented review of all procedure, process and working practice to ensure that they remain fit for purpose for that period in the Project Lifecycle and are achievable. ➢ Failure to adequately plan or manage logistics activities. ➢ Lack of Controlling mind in place to take control of the area and coordinate multiple activities. |

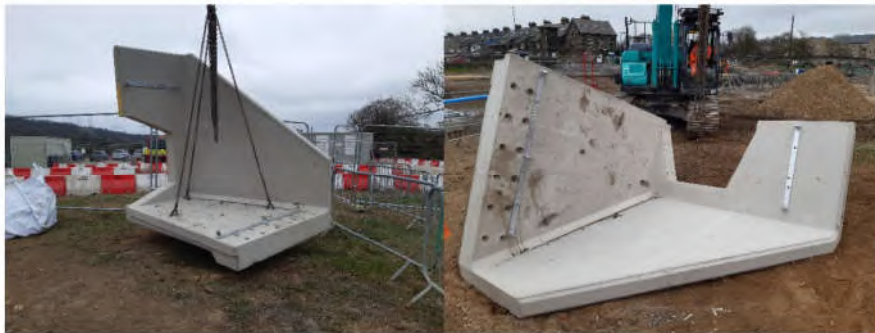
Precast headwall sections were procured for installation into the works. The units were supplied with lifting points installed during manufacture. Although the units were successfully unloaded on delivery, when lifting at a later stage a unit had only just cleared the ground when it rolled over and fell on to the wing wall. Exclusion zones were in place, no injuries and no damage to plant.

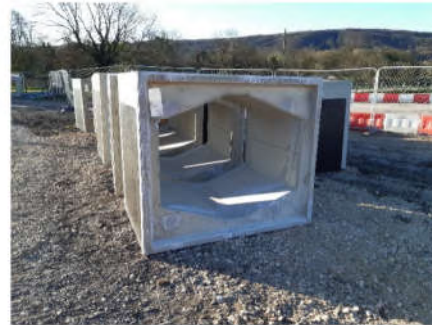
During a site tour, the APL noticed the manufacturers product label on the unit stated a weight of 2.9t. The manufacturer later confirmed 4.8t is correct.

Although no actual incident occurred, it is conceivable that a slinger-signaller might see this label and select lifting accessories too small for this load.

Both precast unit suppliers have been made aware of these incidents and are addressing their issues internally to prevent future reoccurrence.

All APLs and those involved with lifting of any precast units should satisfy themselves that the details provided with the products are suitable and correct and ensure all slinging arrangements are clearly defined on the associated lift plan.

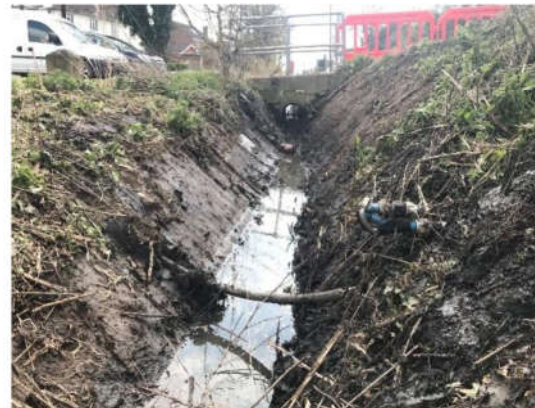
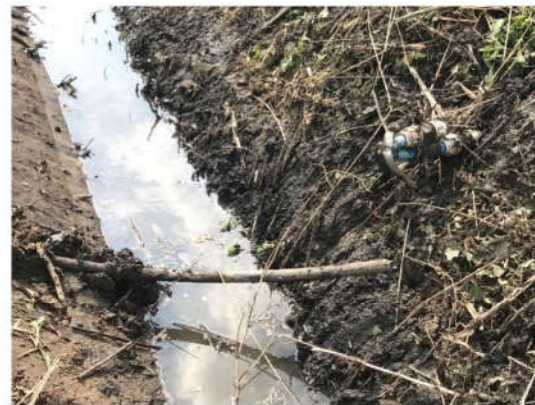
As part of planned site clearance works for the A47 Guyhirn Junction Scheme, a ditch on the edge of the scheme boundary was being cleared using an 8t 360 excavator, with ditching bucket attachment. During the works, an uncharted 25mm black HDPE pipe (high-density polyethylene) private water supply service was damaged. The water supply serviced 4 nearby bungalows built in the 1970s. Anglian Water were alerted and attended site promptly. The repair was fully completed the same afternoon.

- A permit had been issued for the works. The water supply was not charted on any utility drawings and was unable to be picked up when the area had been scanned using service avoidance equipment prior to commencement. The utility was also not picked up by the ground penetrating radar, as the ditch was outside the main construction area.
- The utility pipe was sitting within the silt deposits above the ditch invert level and was not visible prior to excavation. Because the colour of the HDPE (high-density polyethylene) pipe was black instead of blue as standard, this made it even more invisible to identify.
- The repairing Anglian Water Engineer acknowledged that this utility was not laid in accordance with current standards.
- Anglian water is investigating the legality and ownership of this utility.
