September 2021 - STOP Think!

## MEWP Incident (18<sup>th</sup> August 2021)

## Service Strike Lessons Learned (No. 151 - 7<sup>th</sup> August 2021)

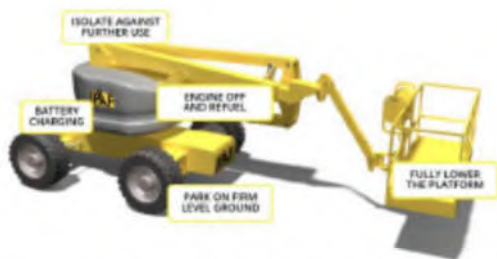
**Correctly stored MEWP - Image courtesy of IPAF**

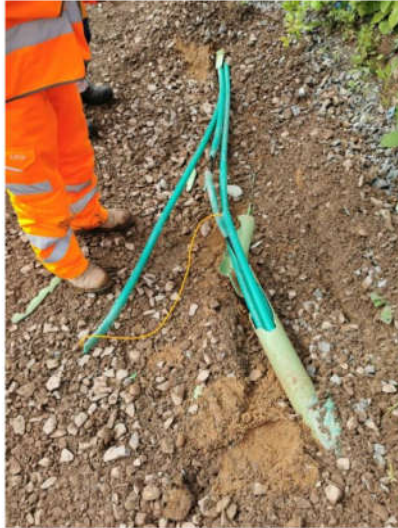
Damaged ducting.

This strike resulted in no injuries, but damage was caused to the 100mm telecoms duct and 2 out of 3 sub ducts were damaged. Following WPDt visit it was confirmed that the cable was damaged at the strike location. This damage to the cable could not be visibly seen at the strike location but was identified through fault finding.

Work was stopped until investigation was completed. WPD undertook a repair of the service.

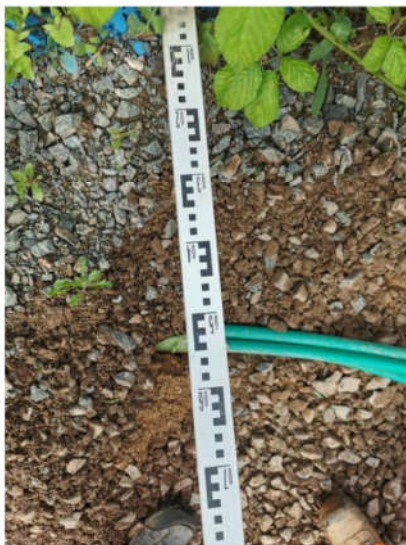
Image showing position of duct in relation to marked location as per as built information.

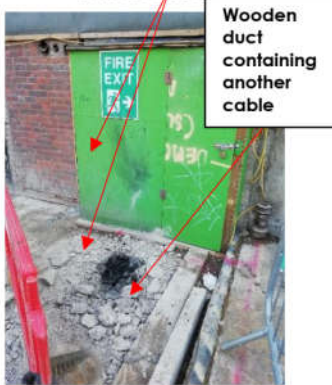
Picture 1 – location that was being broken out by the excavator (Note burn marks from the strike)

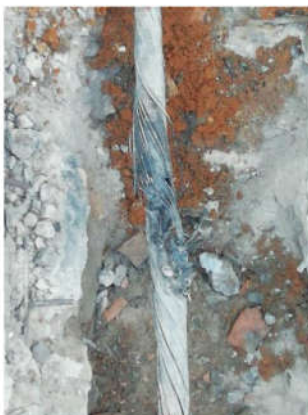
Picture 2 – Cable that was struck.

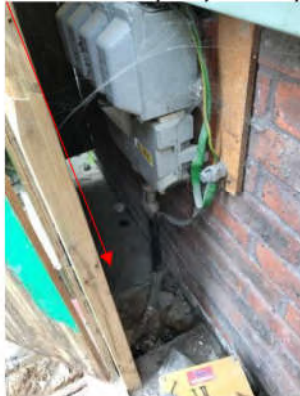
Picture 3 – Visible indication of the struck cable when the temporary door is open

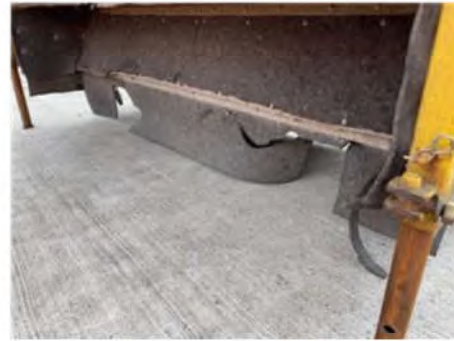
The individual was struck by a ballast stone that was ejected by the ballast brush. It caused a significant, life-changing injury to the left eye and cheek bone.

The ballast brush had been maintained by the supplier before delivery to this site, replacing some missing/damaged tines but not the damaged and shortened rubber skirts that are intended to contain ballast during operation.

- Pre-delivery and pre-use inspections must be undertaken to ensure that there is no damage to the skirt. Any brushes found to have defective skirts shall be quarantined.

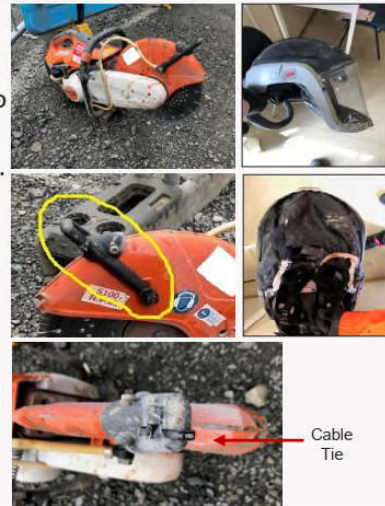
As the IP was cutting the pipe, the Machine has suddenly 'kicked back' and the adjustment lever above the blade guard has struck the IP beneath the chin. The lever had 'teared' through the Versaflow dust shroud and caused the injury.

The direct cause of the laceration has been identified as a 'cable tie', there is conclusive evidence that one was present on the end of the lever while the machine was being used. This has been corroborated by the IP as the reason why the Versaflow shroud was ripped and why the laceration occurred.

- Conduct Toolbox Talks with all tool users and stipulate that cable ties and any hazardous items attached to a tool are removed before use.
- Update risk assessments where required to ensure that a selection process identifies the lowest risk tool for the task, take into account ergonomic, environmental, materials and user considerations.
- Conduct a site audit of all tools/equipment and ensure all items attached which could present a hazard (such as cable ties) are removed.
- Engage with your supplier to remove the use of cable ties for attaching delivery documentation to hired equipment. Remove the risk and the need for single use plastic.
