octavius

STOP.
Think!

March 2023

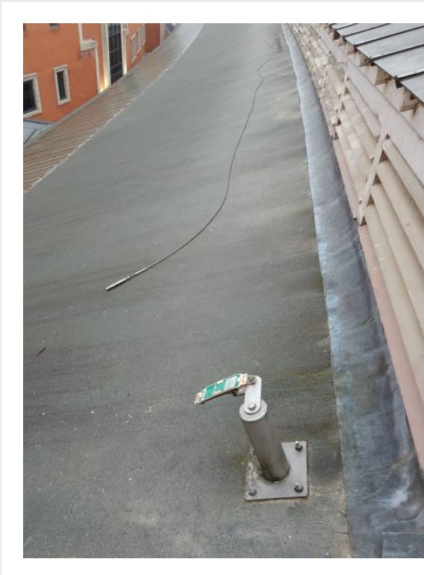
Photo 1 - Failed horizontal wire system

On 14th February 2023 at Windsor and Eton Station, the horizontal wire system failed (often referred to as Man Safe System). This occurred when the operative connected his harness to it whilst traversing from another section of the system using a twin tailed lanyard.

Therefore, pre-use inspection by users should focus on the tension in the wire and on the tensioner(s). In particular, the lock nuts used which should not be loose when visually inspected or move when checked for tightness by hand.

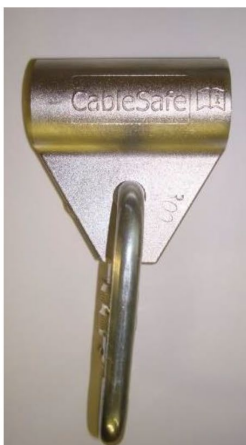
Image 1 – Typical traveller device

- The wearer of the harness/lanyard is trained in its safe use and that it is inspected before each use by the wearer
- The correct traveller device is fitted/available and in use (see image 1)

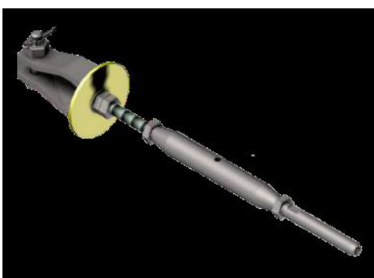
Image 2 - Typical tensioner

The investigation will be focussing on the system’s tensioner (see image 2) as this appears to have failed for reasons to be determined as part of the investigation.

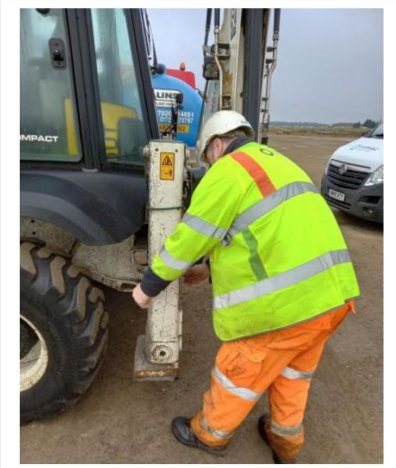
Reconstruction

Stabilising foot of 3CX hydraulically lowered onto IP's left foot

During the reconstruction of A1101 Mildenhall Road, Cambridgeshire a sub-contractor's foreman suffered a fractured toe, lacerations and bruising following a crush injury caused by the lowering of stabilising feet on JCB 3CX Streetmaster.

1. When construction plant is in use, an effective safe system of work is in place and adhered to, which keeps people and plant separated.
2. Are working within the Octavius site rules and adhering to their own company risk assessments and method statements at all times while within the site boundaries
3. Ensure that all elements of the STOPThink! Fundamentals are in place prior to work commencing and remain in place throughout.
4. If in any doubts "Stop, Think" and consult your line manager or SHE Advisor.

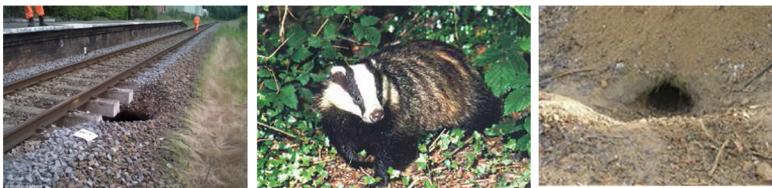
- A badger sett entrance is usually D-shaped and at around 300 millimetres wide by 200 millimetres high
- There may be signs of freshly excavated material at the entrance or piles of leaves, dry grass, straw or bracken, which the badgers take inside to use as bedding.

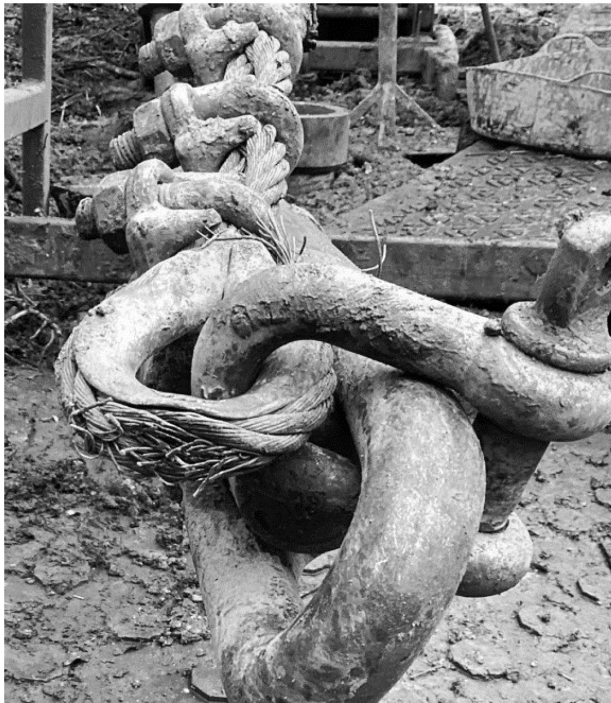
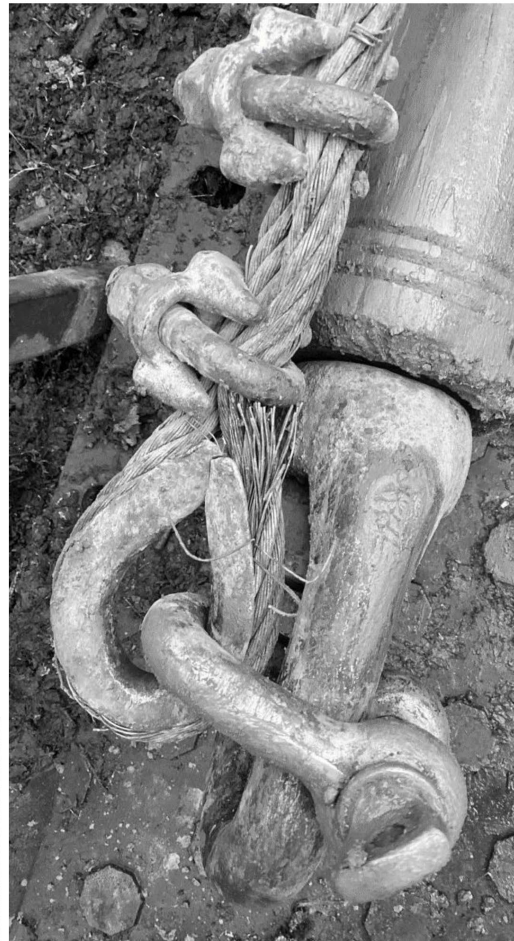
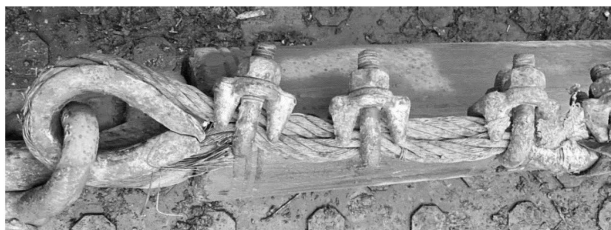
SAFETY ALERT
FEBRUARY 2023

- 16mm galvanized wire rope,
- Had been thoroughly examined less than four months previously by an independent competent person,
- Had been re-terminated using U-bolts since the last thorough examination,
- Had been inspected by the Lead Driller as part of his daily inspection on the day of the audit and had been noted as 'worn'.

The rope had approximately 50% of its strands entirely broken at the pinch-point of the thimble and U-bolt, a high number broken strands at the bottom of the rope within the thimble and there were also numerous broken strands across the entire rope length.

All wire ropes in use on drilling machines should be inspected across their entire length on a regular basis by a competent person. Particular attention should be paid to the thimble area of re-terminated wire ropes in use with cable percussion drilling machines. This check should be documented within both official Thorough Examinations and daily/weekly inspections. All daily/weekly inspections should take note of the rope condition across the entire visible length and should be conducted by a competent operator who has received formal training on how to inspect wire ropes.

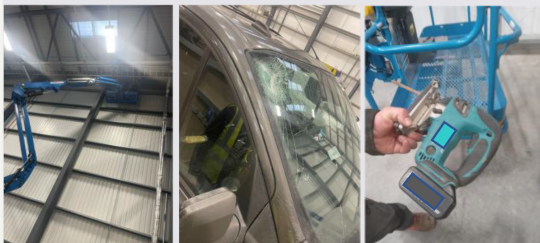
| Work platform | Damage to windscreen | Involved tool |

Whilst using the tool, working at height from an elevated working platform (see pic 1) the battery worked loose and fell from the tool. As the battery fell, it struck a cable tray and changed direction, and subsequently struck a van windscreen that was parked in the area.

Following the incident, the tool was tested. It was found that the battery could be placed onto the tool without being locked in the home position, but the tool could still be powered up. The battery should lock into the tool to prevent it accidentally falling during use, as occurred with this incident.

It is therefore critical that any battery powered tools are checked and checked again to ensure the battery is fully locked, and not rely on its operation as being a check of safe condition.
