Safety Advice

Geismar/MAN 18T MEWP Stabiliser Leg Failure

Ref: NRA23-12

Date of issue: 19/09/2023

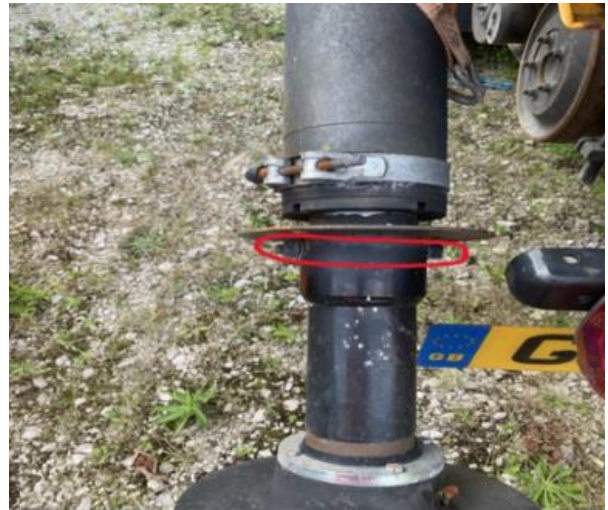
In North West and Central, a Geismar 18T MEWP was found to have a stabiliser foot assembly that had become completely detached from the stabiliser leg. The stabiliser legs are used in conjunction with the crane and can also be used to increase the reach of the basket.

Investigations are ongoing, but initial inspections have indicated that a combination of wear and corrosion have led to the single bolt connecting the foot assembly to the stabiliser leg failing.

- All stabiliser legs and feet assemblies to be thoroughly inspected by a competent person.
- Do not use the stabiliser legs on the Geismar 18T MEWPs until the inspection has been completed and any required remedial work has been carried out.
