STOPThink!

Injury to foot from nail

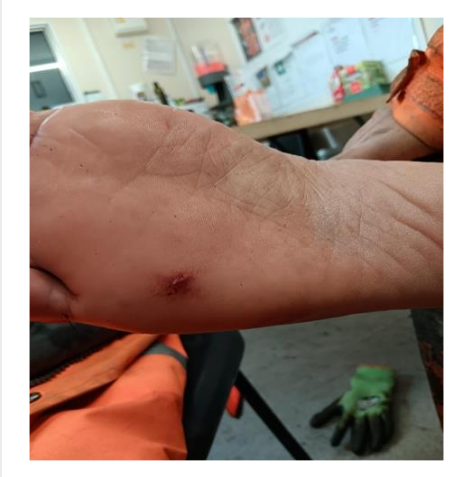
Penetration wound to sole of foot.

Whilst in the course of their duties, the operative stood on a nail protruding from some timber that had been left behind following previous works by others. The nail penetrated the sole of the operative's safety boot and caused an injury.

- As soon as timber is removed from use, nails and screws should either be removed or knocked down to make them safe.
- Ensure that you have the correct levels of protection on your safety footwear. The label on the inside of a work boot should detail 'S3'. This confirms that the boot has midsole protection as well as other required safety measures.
- Utilise the point of work risk assessment (POWRA) to help identify hazards immediately before works commence so that they can be removed or controlled.
- Do not wait for others to clear debris from previous works. Review work areas and take action to make the area safe to work in.
- If you have any concerns or questions, "STOPThink!" and consult with your Supervisor or your Safety representative.

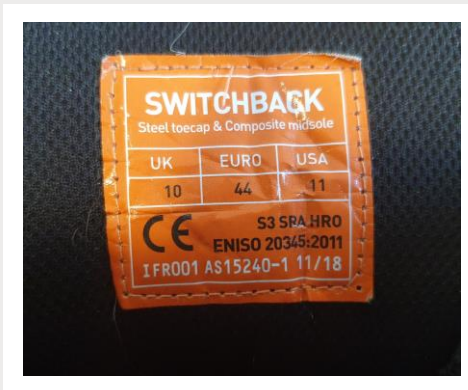
Correct specification of safety footwear
Note that the label references 'S3'.
