STOPThink! Hoarding Stability

Undesigned Hoarding on OIL site.

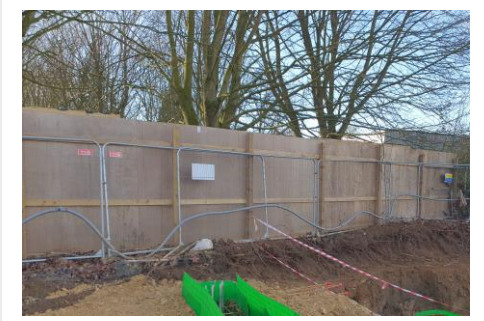
A timber hoarding was erected on an Octavius project without a temporary works design. It was subsequently undermined by excavations in the area, which further reduced the stability of the hoarding.

1. A short-term management plan to mitigate the risks to the public and our workforce was agreed between the Engineering Team and the TWC until an as built design assessment could be undertaken.
2. Design assessment found that the hoarding was over designed (inefficient) in some areas, but crucially under designed in others and could have potentially blown over if exposed to a worst case 2-year storm event.
3. Additional intermediate posts are now being installed to stabilise the hoarding.

- Appoint an approved Temporary Works Coordinator
- Identify requirements for Temporary Works and list on TW Register
- Prepare a Temporary Works Brief for any hoardings, which are required on the project putting in a request to the Engineering Team (or a competent supplier) for a design
- Ensure all temporary (or permanent) hoardings are not constructed until a design is completed
- Seek advice from the hoarding designer if they think there is a risk of the hoarding being undermined by any nearby earthworks.
- Take note of the guidance by the [Temporary Works Forum for Hoarding Stability](#)

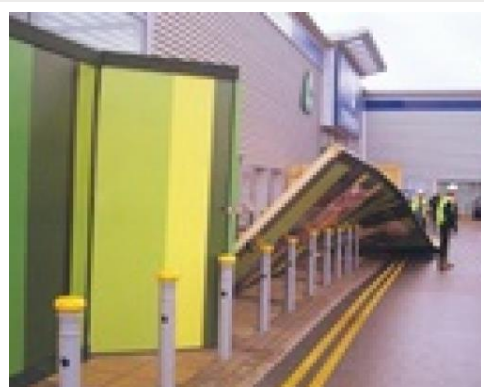
Case Study: 2019 Site Hoarding Collapse
Member of the public suffered major injury resulting in a £250,000 fine.
