PURPOSE OF THE SAFETY ALERT

Following a couple of recent incidents on GRAHAM sites, we wish to remind sites of the following rules in relation to tipping areas and bucket changing requirements.

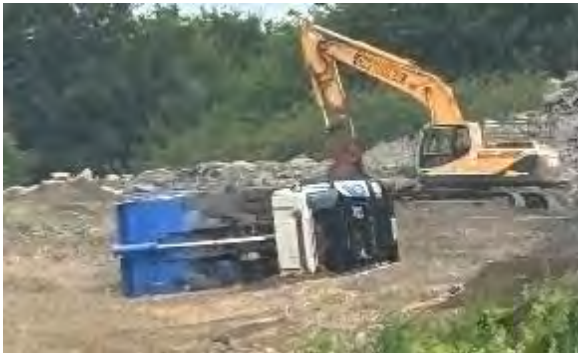
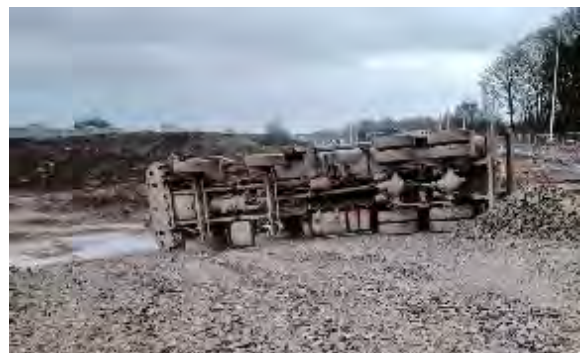
We have unfortunately had 2no tipper lorries go over onto their sides recently – one with no injuries to the driver and one that ended being RIDDOR reportable. Ground conditions played a fundamental part in the root cause analysis of both incidents along with an unbalanced load that the driver had tried to ‘shake free’.

Tipping areas should be managed in the same way as any other part of the site and should be level, firm and stable, with the tipping area able to hold the vehicle and load during tipping. It should be clear of overhead lines and services, and away from pedestrian walkways. The vehicle should remain level at all times, even if it is driven forward during tipping. Articulated vehicles must be tipped with the cab and trailer in line.

No one should be permitted to stand or walk behind the vehicle when the body is raised or during tipping, and when raising or lowering the body, the driver should never leave the vehicle and should make sure that the cab doors are closed.

Drivers should be experienced enough to anticipate loads sticking and must never drive in order to shake free a stuck load. If the load does stick, the body must be lowered, and the load freed before the body is raised again. The driver should always make sure that the body is completely empty after tipping and should not drive more than a few metres forward to make sure the load is clear, and should only do this after checking the load is at the bottom of the tipping body.

Wheel-stops must be used when possible to help position vehicles.

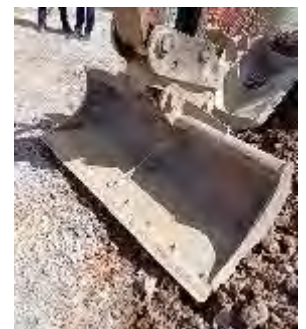
During the changing operation involving a 13T excavator and ditching bucket, the driver accidentally knocked the bucket into an adjacent shallow excavation, causing injury to an operative in the excavation. The operative suffered no broken bones but was off work for more than 3 days, making it RIDDOR reportable.

Sites should have dedicated bucket changing areas away from workers, pedestrians, walkways, services or other plant and equipment that could be damaged. Areas should be identified and not used for other purposes. They should be clearly marked on the site Traffic Management Plan and referred to in the associated and relevant RAMS. Unauthorized persons should be excluded from these areas during bucket changing operations.
