Pierced Traction Cables

Ref: NRB23-07

Date of issue: 29/06/2023

Location: Gillingham & Gravesend, Kent

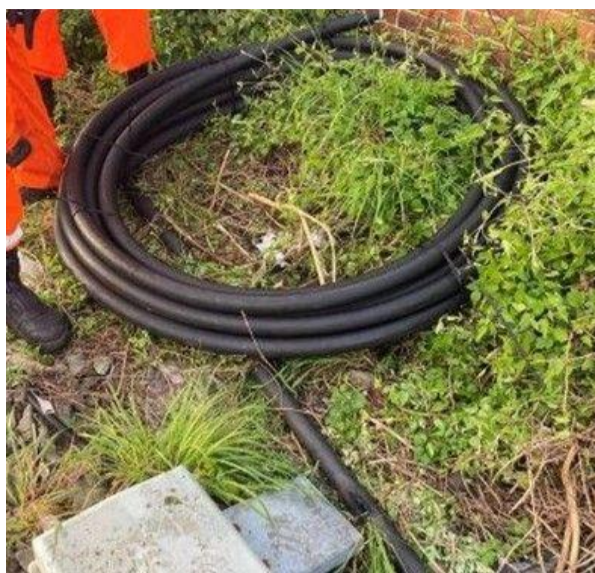
On 4th May 2023, EK2033B points at Gillingham pierced a live traction cable that had become caught in the point machine. The incident punctured the insulation of the cable causing a short circuit and damage to the point machine. The short circuit meant that the lock/detection blades became live and could have caused injury to any operator using the manual winding mechanism.

The section of cable which was pierced was due to be replaced as part of planned project work that night. The coiled-up section had been delivered to site for this replacement work. This cable was propped up against the wall and subsequently slipped down, pushing the live cable section towards the point machine. Subsequent operations of the points led to the machine blade ends coming into contact with the cable and ultimately pierce / puncture its insulation layers, exposing the live conductor cable. Following a point movement, the lock / detection blades came into contact with the live conductor causing a short circuit.

The Route has commenced a specific check on all point machines on the area and already identified two further point ends where action is required to remove the risk.
