### HS&W Immediate Notification – Immediate stand down of Skyjack Vertical Mast MEWPs

Immediate Notification Details:			
Project / Office:	<b>Industry wide</b>	Incident Category:	Near Miss
Region:	Group Services	Potential Severity:	Level 5 - High Potential Incident
Date of Incident(s):	16/06/2023    Various <input type="checkbox"/>	HS&W Category:	LOLER - Lifting Operations
Alert Author:	<b>Craig Hook</b>	Work Activity / Trade:	<b>Lifting Operations</b>

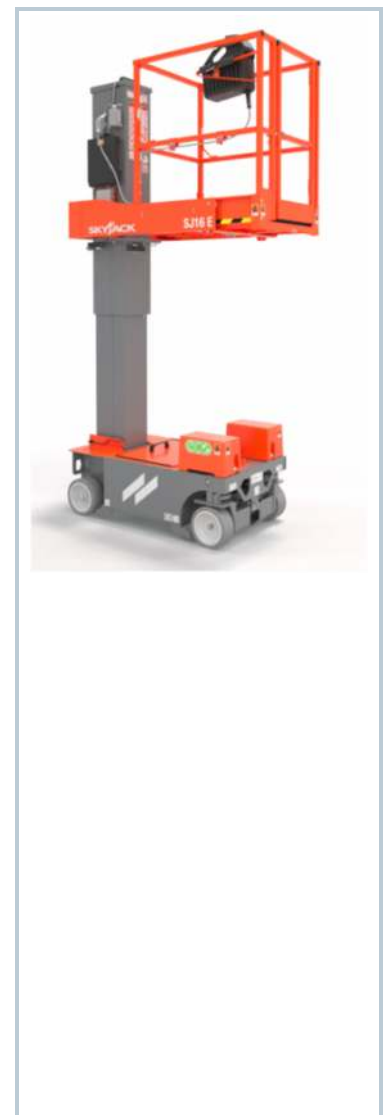
This is not an SRM incident but is relevant to all projects and must be actioned.  
 A plant fitter was working on a MEWP when the MEWP mast became disconnected from the base of the machine, due to the failure in the weld. The mast rotated but was caught by the internal hydraulic ram. This resulted in the MEWP overturning.

1. The activity was stopped immediately.
2. Conversations were held with Skyjack who have subsequently investigated and highlighted a potential flaw in the method of connecting the mast to the chassis that can lead to a failure in the weld.

1. Stand down the following Skyjack machines: SJ12E, SJ16E, SJ20E until Skyjack Service Bulletin #168 has been applied to the equipment and the serial number verified.  
**Models Affected: SJ12E, SJ16E, SJ20E**

**Serial Ranges:**  
 SJ12E: A601000906 through A601005185  
 SJ16E: A601000909 through A601005478  
 SJ20E: A601000763 through A601005631
- 2.
3. If a machine is found on your project, you must quarantine it and isolate so that it cannot be used until it can be collected from site by the rental company / owner.
